ECO INSPECTION CERTIFICATE

121 Points Vehicle Inspection Certificate

Ordered By : ZAHEER SHAFIQ SHAIKH	Inspection Date : 2019-12-18	Location : PUNE	Inspected By

Renault Pulse RxZ Petrol, 2015

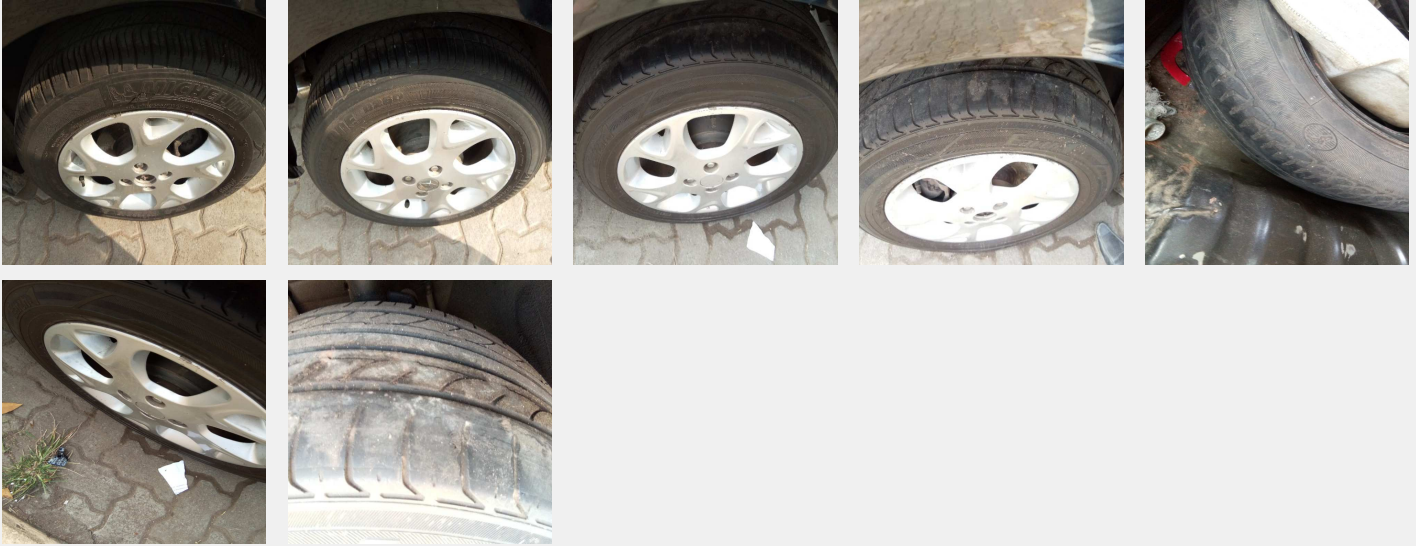
IMAGES

INSPECTION CHECKPOINTS	SCORE(X/10)	REMARKS/COMMENTS	OPTIONAL SPEND EST. (RS)
TYRES	6	TIRES ARE IN AVERAGE CONDITION	0
SPARE TYRE (YES)	6	SPARE TYRE IS IN AVERAGE CONDITION	0
WHEEL ASSEMBLY (ALLOY RIM)	8	WHEEL ASSEMBLY IS IN GOOD CONDITION	0

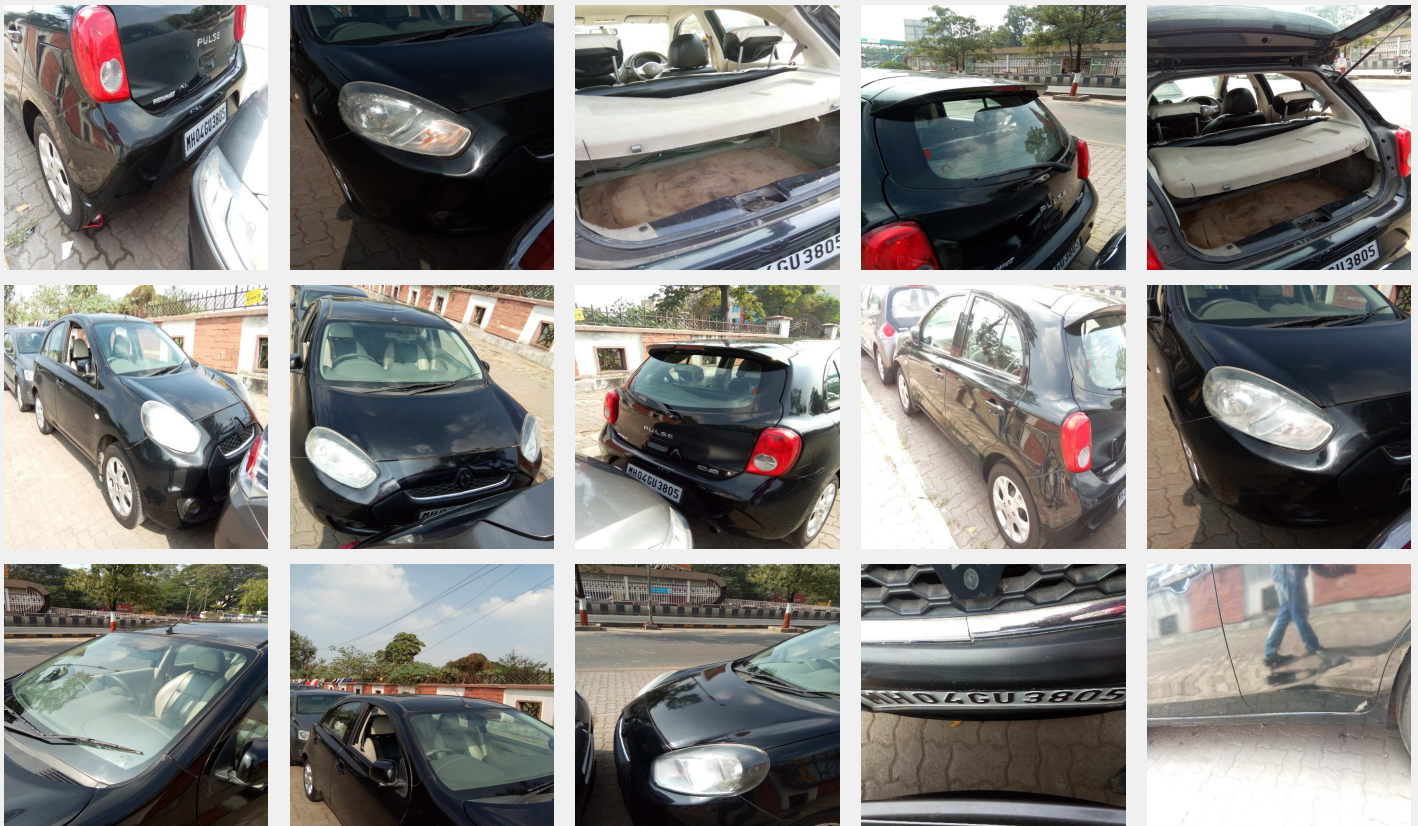
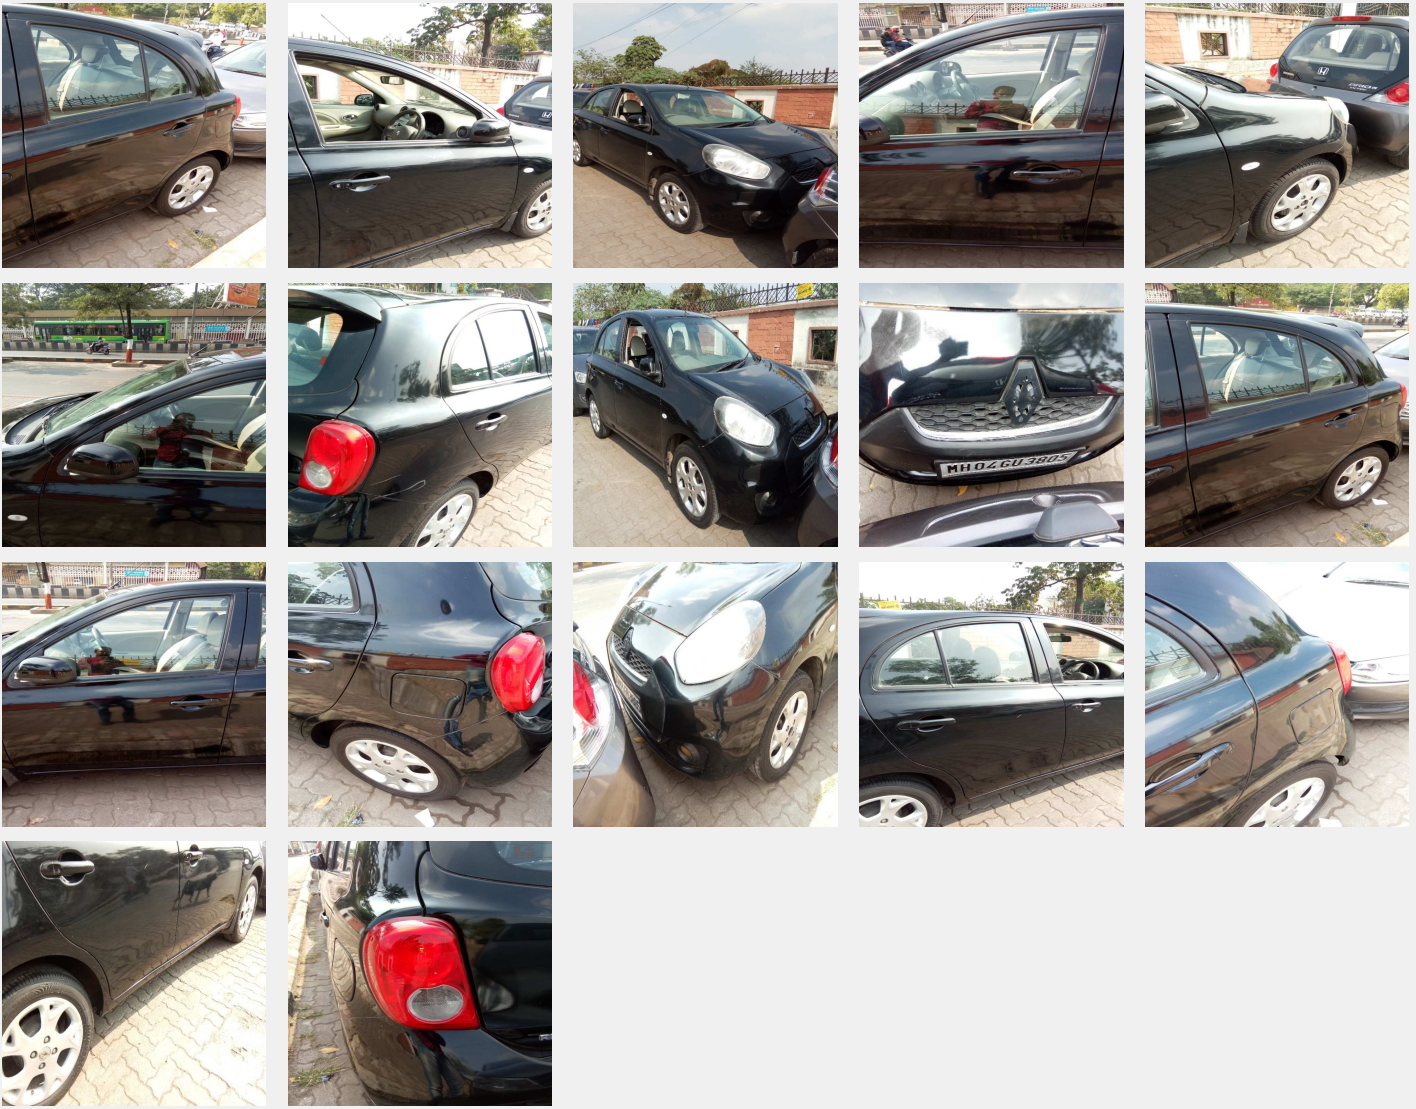
IMAGES

INSPECTION CHECKPOINTS	SCORE(X/10)	REMARKS/COMMENTS	OPTIONAL SPEND EST. (RS)
RH FENDER	6	RH FENDER IS IN AVERAGE CONDITION	0
BODY RUST	6	BODY RUST 25%-MINOR	0
ROOF (REGULAR)	6	ROOF IS IN AVERAGE CONDITION	0
PAINT CONDITION	6	PAINT IS IN AVERAGE CONDITION	0
FOG LAMPS	4	FOG LAMPS CRACKED-MINOR	2000
