ECO INSPECTION REPORT

Order ID : 24782

Ordered By : Anurag | Inspection Date : 2018-09-30 | Valid Till : 2018-12-30

Fiat Linea Emotion 1.3, 2010

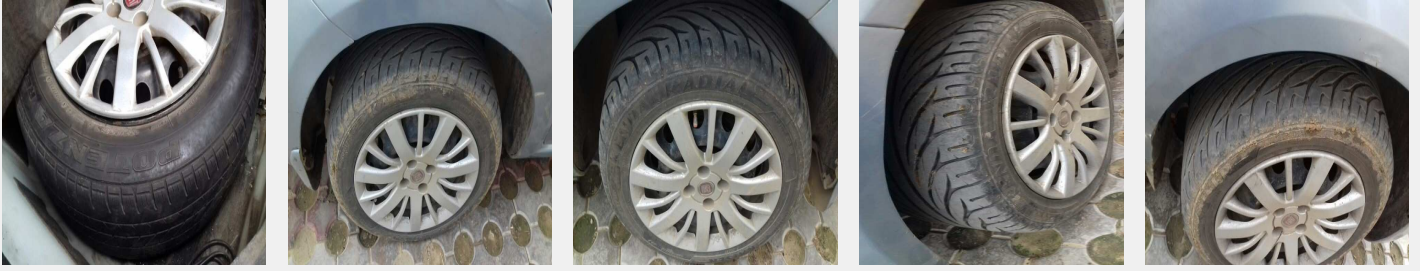
| INSPECTION CHECKPOINTS | SCORE(X/10) | REMARKS/COMMENTS | OPTIONAL SPEND EST. (RS) |
|---|---|---|---|
| TYRES | 7 | GOOD | 0 |
| SPARE TYRE (YES) | 6 | GOOD | 0 |
| WHEEL ASSEMBLY | 6 | GOOD | 0 |
