# ECO INSPECTION CERTIFICATE

Order ID : 32696

121 Points Vehicle Inspection Certificate

## Maruti Suzuki Baleno ZETA 1.2, 2016

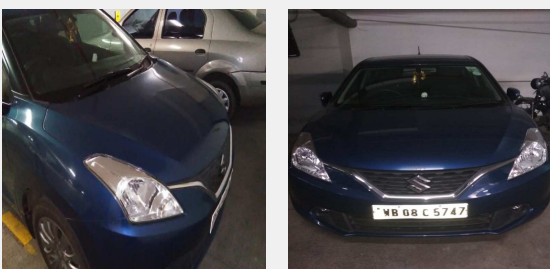
IMAGES

HOOD

| INSPECTION CHECKPOINTS | SCORE(X/10) | REMARKS/COMMENTS | OPTIONAL SPEND EST. (RS) |
|---|---|---|---|
| EXHAUST SYSTEM | 6 | AVERAGE | 0 |

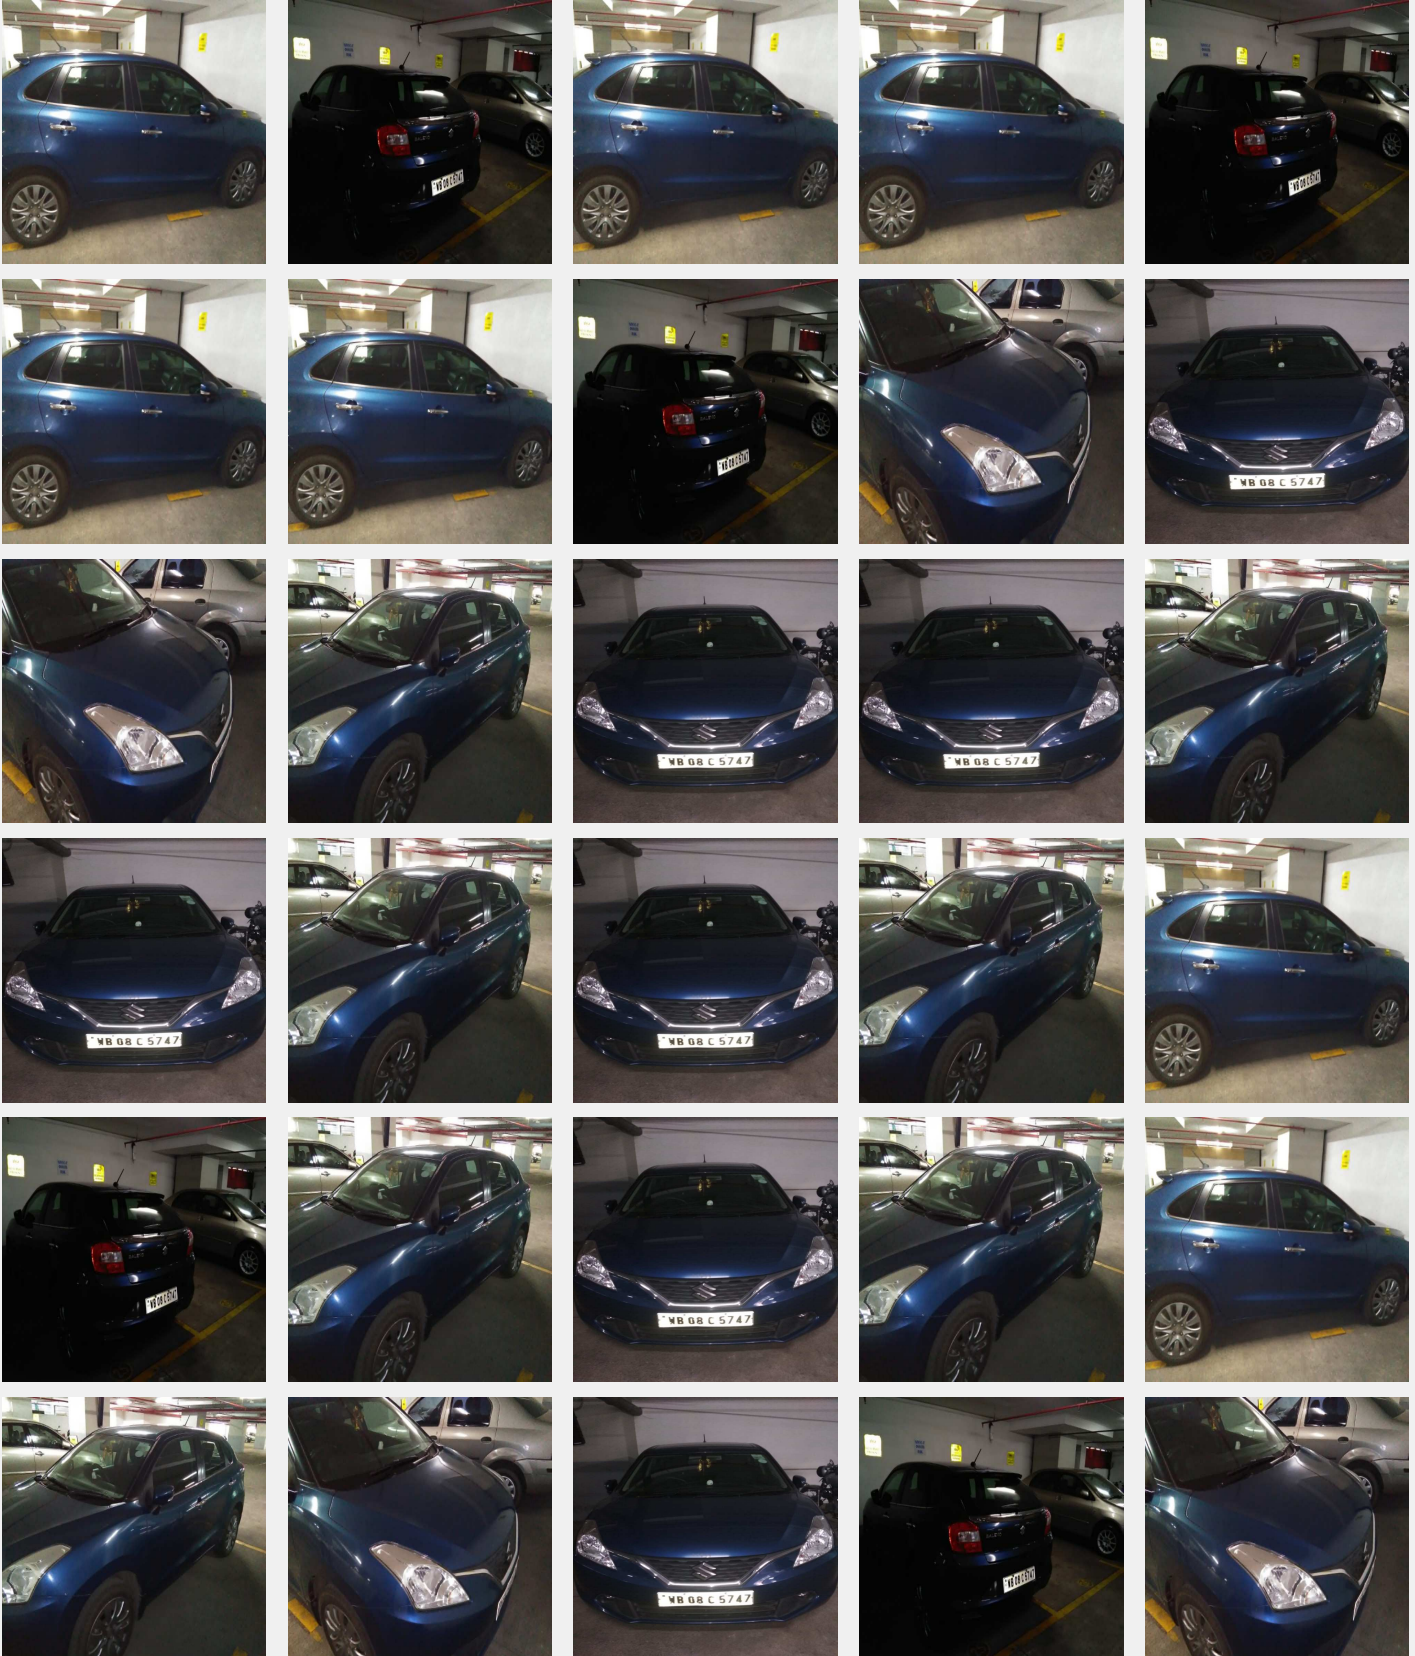
IMAGES

| INSPECTION CHECKPOINTS | SCORE(X/10) | REMARKS/COMMENTS | OPTIONAL SPEND EST. (RS) |
|---|---|---|---|
| LICENSE PLATE | 5 | NEED TO REPLACED | 500 |
