ECO INSPECTION CERTIFICATE

121 Points Vehicle Inspection Certificate

Ford Endeavour TITANIUM 3.2 4X4 AT, 2017

MAKE	FORD	TRANSMISSION TYPE	AUTOMATIC
MODEL	ENDEAVOUR	REGISTRATION NO.	HR26DB5159
YEAR	2017	VIN/CHASIS NUMBER	55300
TRIM	TITANIUM 3.2 4X4 AT	KMS RUN	20478
COLOR	RED	INSURANCE EXPIRY	2018-12-6
BODY TYPE	SUV	LOCATION	DELHI
FUEL TYPE	DIESEL	ENGINE SOUND LINK	LISTEN ENGINE SOUND

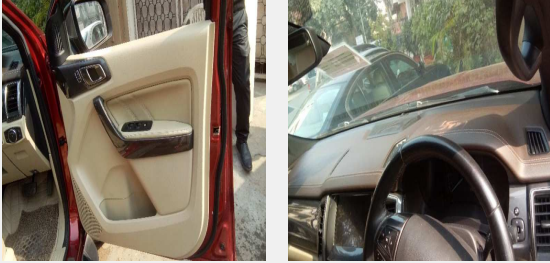
INSPECTION CHECKPOINTS	SCORE(X/10)	REMARKS/COMMENTS	OPTIONAL SPEND EST. (RS)
DOOR PANEL	8	GOOD	0
DOOR HINGES	7	GOOD	0
CARPET & FLOOR MAT	7	GOOD	0
SEAT & SEAT BELT	7	GOOD	0
DASHBOARD & INSTRUMENT PANEL	7	GOOD	0
HORN	8	GOOD	0
SPEAKERS & MUSIC SYSTEM	7	GOOD	0
HANDBRAKE	8	GOOD	0
STEERING-MOUNTED CONTROLS	7	GOOD	0
PEDALS	8	GOOD	0
CENTRAL LOCK	7	GOOD	0
A/C VENTS & HEATER	8	GOOD	0
CUP HOLDERS	7	GOOD	0
NAVIGATION (YES)	8	GOOD	0
ODOMETER	8	GOOD	0
POWER WINDOWS (YES)	8	GOOD	0
HAZARD LIGHT	8	GOOD	0

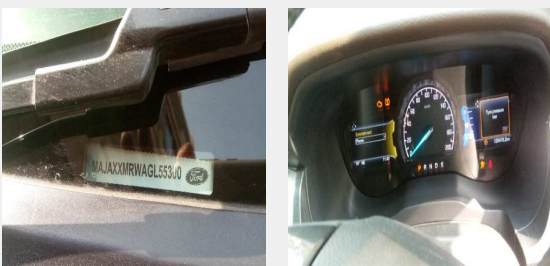
IMAGES

INSPECTION CHECKPOINTS	SCORE(X/10)	REMARKS/COMMENTS	OPTIONAL SPEND EST. (RS)
STEERING PERFORMANCE	8	GOOD	0
BRAKE PERFORMANCE	7	GOOD	0
CLUTCH PERFORMANCE	7	GOOD	0
ENGINE NOISE	7	GOOD	0
IGNITION SYSTEM	8	GOOD	0
SUSPENSION PERFORMANCE	8	GOOD	0
SUSPENSION FRONT SHOCKS	8	GOOD	0
SUSPENSION REAR SHOCKS	7	GOOD	0
TRANSMISSION ENGAGE	8	GOOD	0
CRUISE CONTROL (YES)	7	GOOD	0
REAR PARKING SENSORS (YES)	8	GOOF	0
REAR VIEW CAMERA (YES)	8	GOOD	0

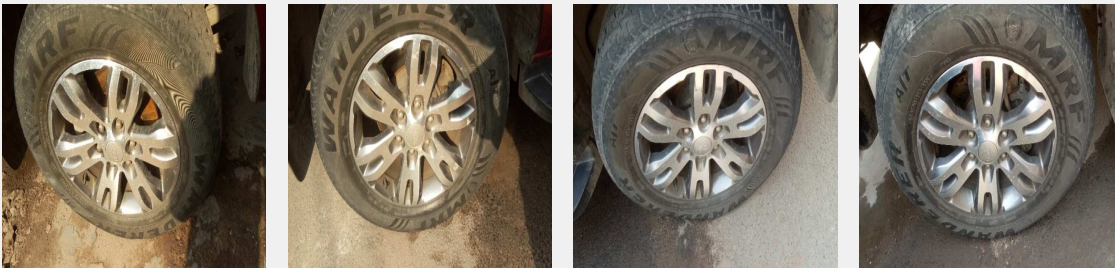
IMAGES

INSPECTION CHECKPOINTS	SCORE(X/10)	REMARKS/COMMENTS	OPTIONAL SPEND EST. (RS)
TYRES	6	FAIR CONDITION	0
SPARE TYRE (YES)	7	GOOD	0
WHEEL ASSEMBLY (STEEL RIM)	7	GOOD	0

minor scratches in body rear tyre weak overall good condition

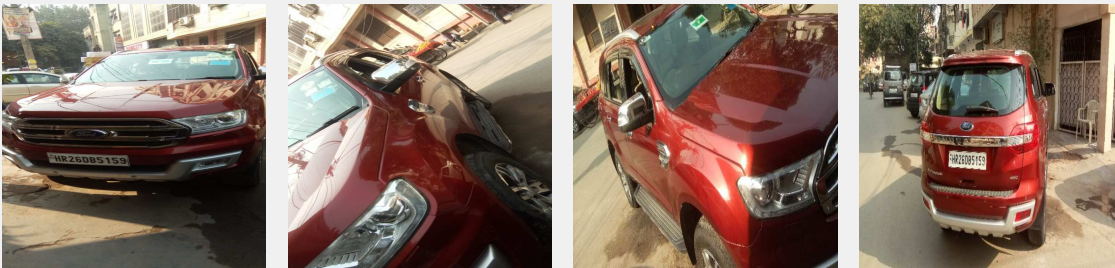
IMAGES

INSPECTION CHECKPOINTS	SCORE(X/10)	REMARKS/COMMENTS	OPTIONAL SPEND EST. (RS)
RH FRONT DOOR	7	GOOD	0
RH FENDER	7	GOOD	0
BODY RUST	8	GOOD	0
ROOF (SUN ROOF)	7	GOOD	0
PAINT CONDITION	8	GOOD	0
