# ECO INSPECTION CERTIFICATE

Order ID : 36619

121 Points Vehicle Inspection Certificate

## Bmw X1 SDRIVE20D, 2012

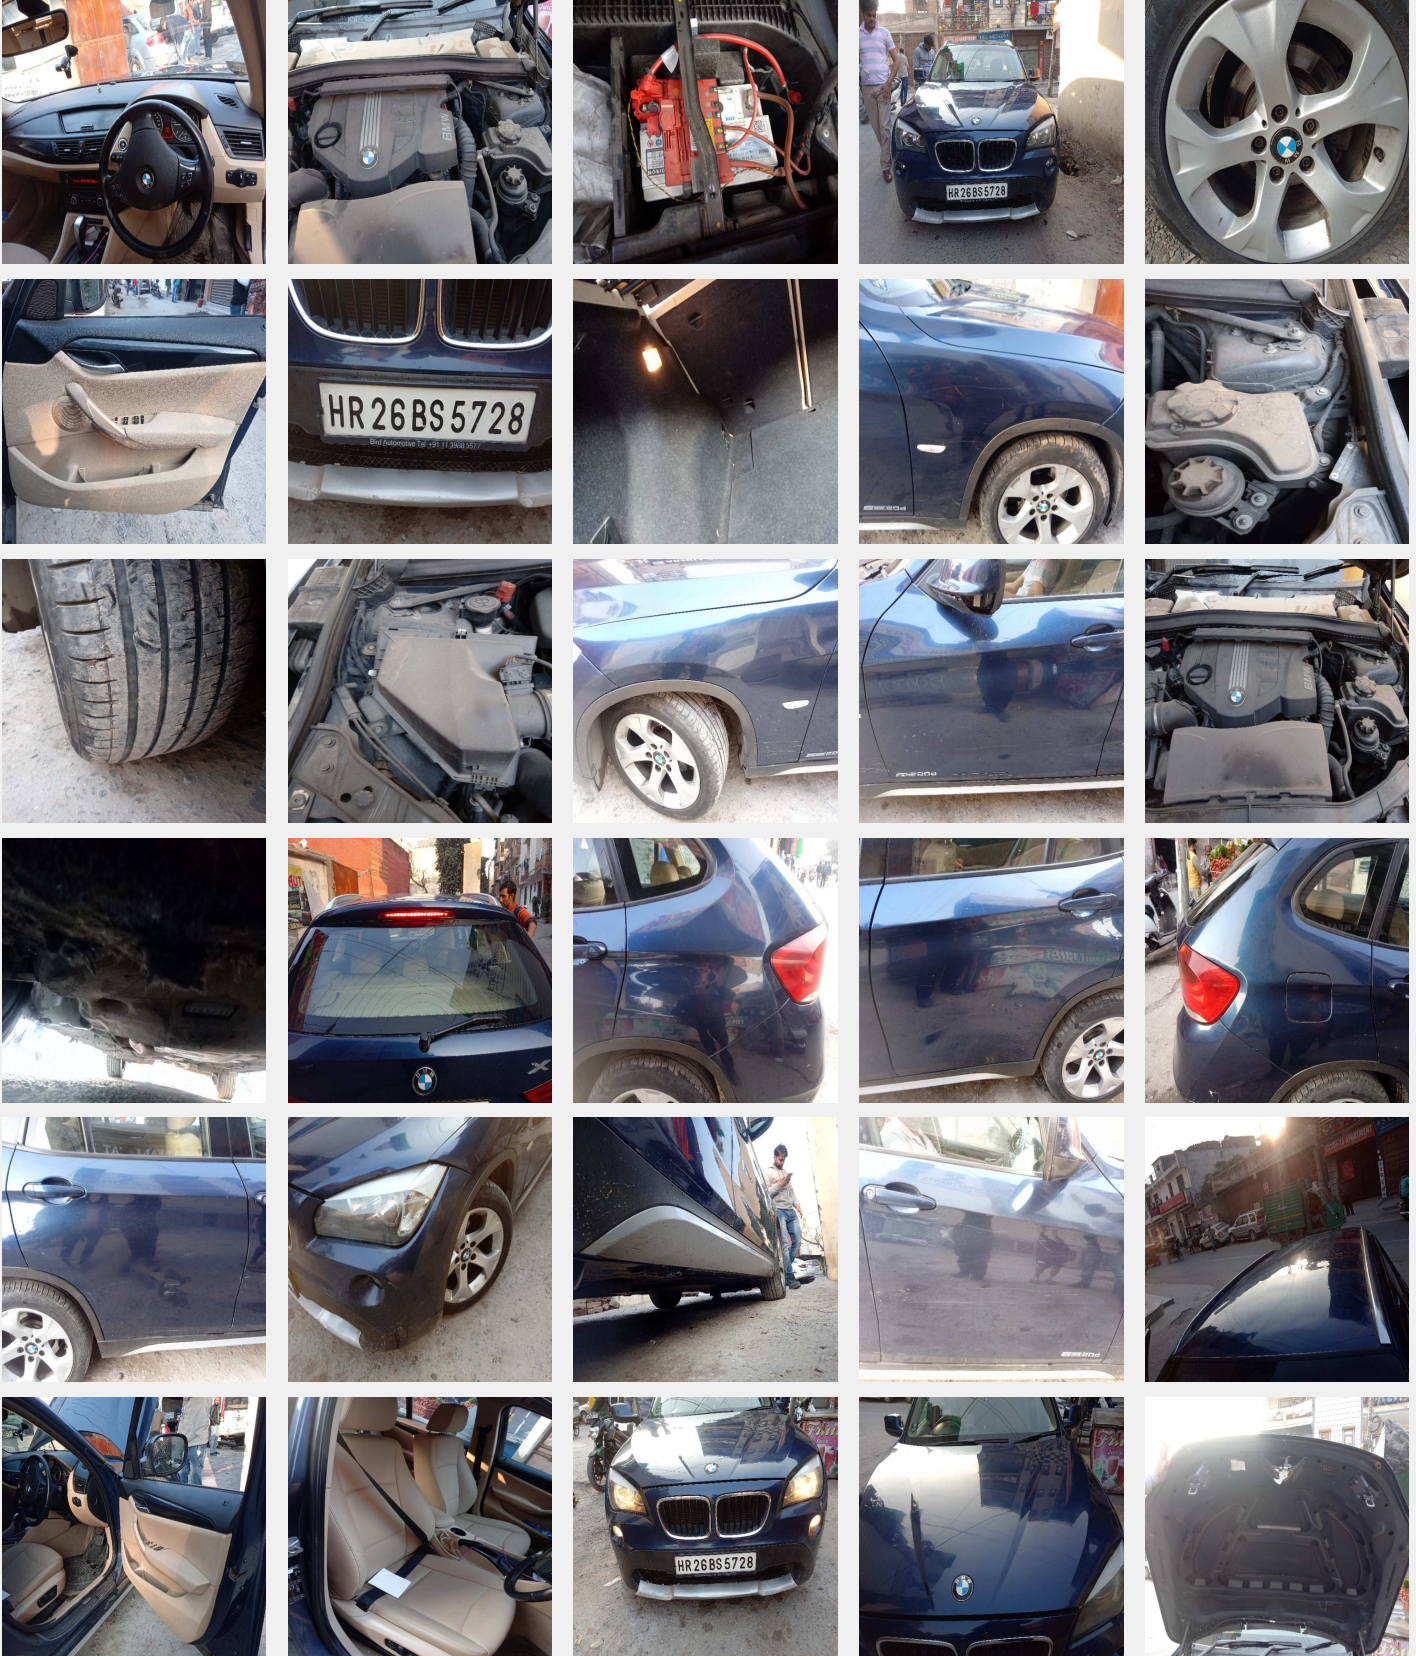
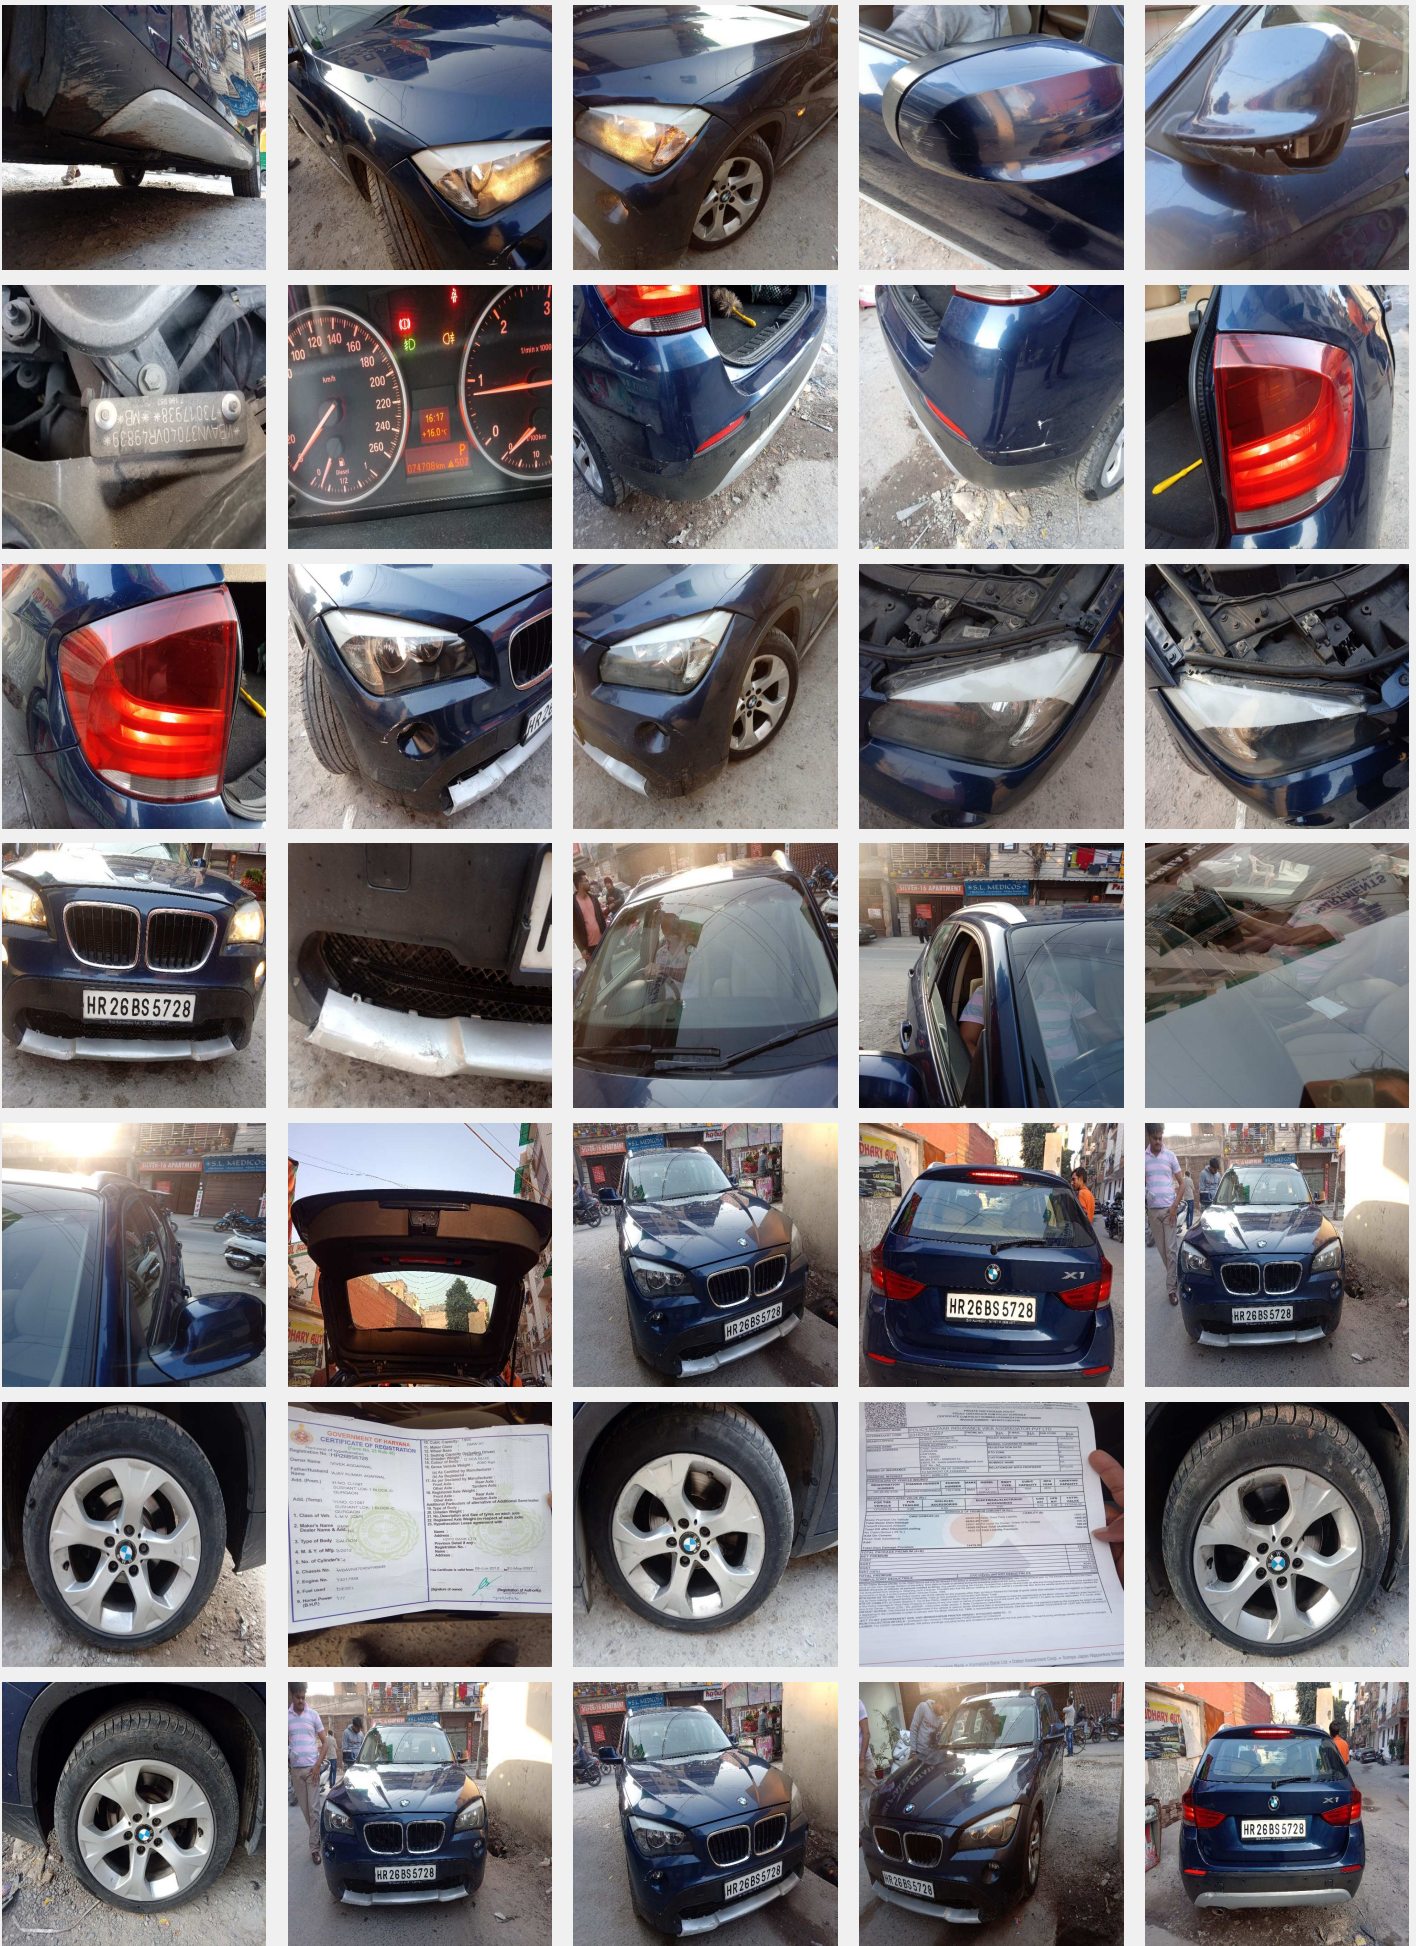
IMAGES

INSPECTION CHECKPOINTS	SCORE(X/10)	REMARKS/COMMENTS	OPTIONAL SPEND EST. (RS)
TAIL LIGHT	4	RHS CRACK NEED REPLACE	20000
RH QUARTER PANEL	4	SCRATCHES AND DENT NEED REPAIR	20000
RH REAR DOOR	4	SCRATCHES AND DENT NEED REPAIR	35000
RH FRONT DOOR	4	SCRATCHES AND DENT NEED REPAIR	30000
PAINT CONDITION	5	SCRATCHES AND DENT NEED REPAIRING AND TOUCHING	50000

all body having Dent and scratches need repairing
