ECO INSPECTION CERTIFICATE

Order ID : 40739

121 Points Vehicle Inspection Certificate

Bmw 5 Series 520D, 2008

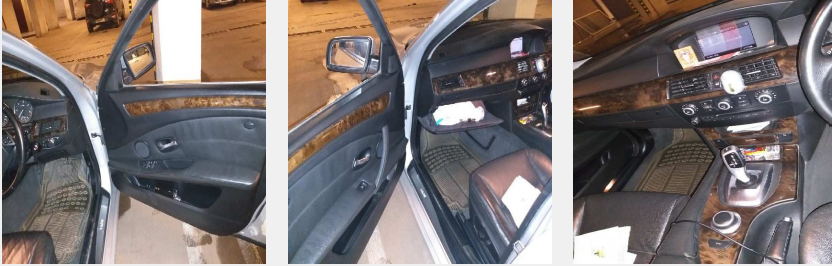
INSPECTION CHECKPOINTS	SCORE(X/10)	REMARKS/COMMENTS	OPTIONAL SPEND EST. (RS)
DOOR PANEL	8	GOODCONDITION AND WORKING PROPERLY	0
DOOR HINGES	8	GOODCONDITION AND WORKING PROPERLY	0
CARPET & FLOOR MAT	8	GOOD	0
SEAT & SEAT BELT	8	GOODCONDITION AND WORKING PROPERLY	0
DASHBOARD & INSTRUMENT PANEL	8	GOODCONDITION AND WORKING PROPERLY	0
HORN	8	GOODCONDITION AND WORKING PROPERLY	0
SPEAKERS & MUSIC SYSTEM	8	GOODCONDITION AND WORKING PROPERLY	0
HANDBRAKE	8	GOODCONDITION AND WORKING PROPERLY	0
STEERING-MOUNTED CONTROLS	8	GOODCONDITION AND WORKING PROPERLY	0
PEDALS	8	GOODCONDITION AND WORKING PROPERLY	0
CENTRAL LOCK	8	GOODCONDITION AND WORKING PROPERLY	0
A/C VENTS & HEATER	8	GOODCONDITION AND WORKING PROPERLY	0
CUP HOLDERS	8	GOOD	0
NAVIGATION (YES)	8	GOOD	0
ODOMETER	8	GOODCONDITION AND WORKING PROPERLY	0
POWER WINDOWS (YES)	8	GOODCONDITION AND WORKING PROPERLY	0
HAZARD LIGHT	8	GOODCONDITION AND WORKING PROPERLY	0

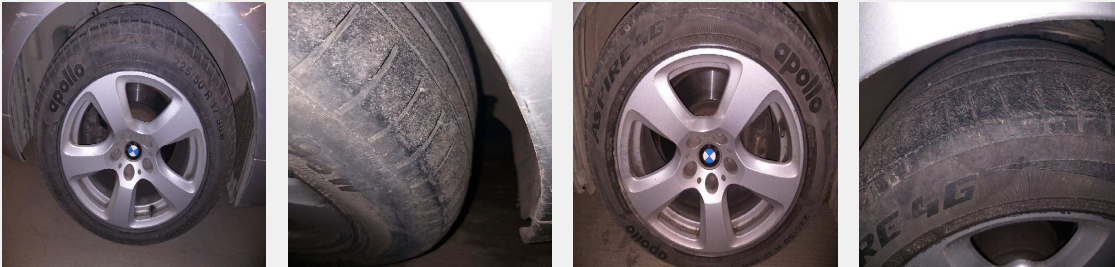
INSPECTION CHECKPOINTS	SCORE(X/10)	REMARKS/COMMENTS	OPTIONAL SPEND EST. (RS)
TYRES	7	NORMAL CONDITION	0
SPARE TYRE (NO)	10		0
WHEEL ASSEMBLY (ALLOY RIM)	8	GOODCONDITION AND WORKING PROPERLY	0

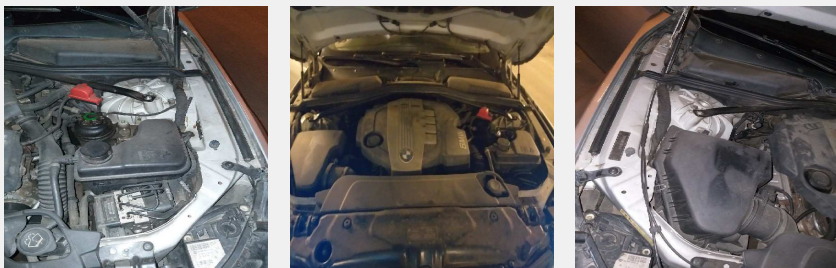
INSPECTION CHECKPOINTS	SCORE(X/10)	REMARKS/COMMENTS	OPTIONAL SPEND EST. (RS)
LH APRON	8	GOOD	0
RH APRON	8	GOOD	0
RADIATOR	8	GOODCONDITION AND WORKING PROPERLY	0
WIRING	8	GOODCONDITION AND WORKING PROPERLY	0
		GOODCONDITION AND

BATTERY	8	WORKING PROPERLY	0
BRAKE FLUID LEVEL	8	MAXIMUM LAVAL	0
ENGINE OIL	8	MAXIMUM LAVAL	0
COOLANT LEVEL	8	MAXIMUM LAVAL	0
BRAKE & COOLANT HOSE PIPES	8	GOODCONDITION AND WORKING PROPERLY	0
UNDERCARRIAGE	8	GOOD	0
EXHAUST SYSTEM	8	GOOD	0
