ECO INSPECTION CERTIFICATE

Order ID : 37389

121 Points Vehicle Inspection Certificate

Hyundai Accent EXECUTIVE, 2008

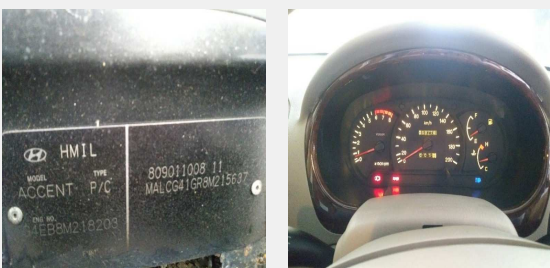
IMAGES

INSPECTION CHECKPOINTS	SCORE(X/10)	REMARKS/COMMENTS	OPTIONAL SPEND EST. (RS)
STEERING PERFORMANCE	6	GOOD	0
BRAKE PERFORMANCE	6	GOOD BRAKE	0
CLUTCH PERFORMANCE	6	OPERATING NORMAL	0
ENGINE NOISE	6	NORMAL ENGINE NOISE	0
IGNITION SYSTEM	6	WORKING PROPERLY	0
SUSPENSION FRONT SHOCKS	6	MINIMUM SHOCK	0
SUSPENSION REAR SHOCKS	6	MINIMUM SHOCK	0
TRANSMISSION ENGAGE	6	PROPER ENGAGE	0
CRUISE CONTROL (NO)	10		0
REAR PARKING SENSORS (NO)	10		0
REAR VIEW CAMERA (NO)	10		0
SUSPENSION PERFORMANCE	5	GOOD	0

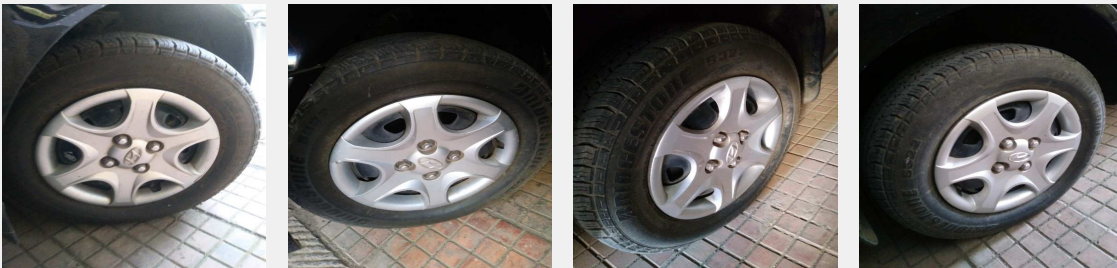
IMAGES

INSPECTION CHECKPOINTS	SCORE(X/10)	REMARKS/COMMENTS	OPTIONAL SPEND EST. (RS)
TYRES	6	NO WEAR TEAR GOOD TREAD	0
SPARE TYRE (YES)	6	ACCEPTABLE CONDITION	0
WHEEL ASSEMBLY (STEEL RIM)	6	NO BEND ON IT	0

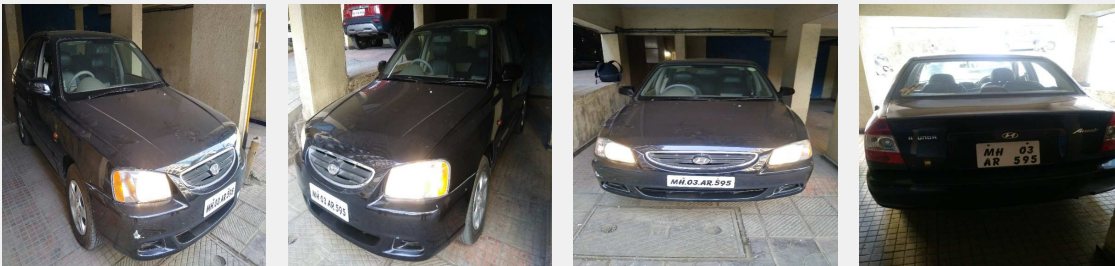
IMAGES

INSPECTION CHECKPOINTS	SCORE(X/10)	REMARKS/COMMENTS	OPTIONAL SPEND EST. (RS)
ROOF (REGULAR)	6	GOOD CONDITION	0
PAINT CONDITION	6	GOOD	0
FRONT BUMPER	4	NEED TO REPAINT REPAIR	2000
LH RUNNING BOARD	5	DENT ON IT	2000
RH QUARTER PANEL	5	NEED TO REPAINT	2000
