# ECO INSPECTION CERTIFICATE

Order ID : 41542

121 Points Vehicle Inspection Certificate

## Mahindra Kuv100 K8 6 STR, 2016

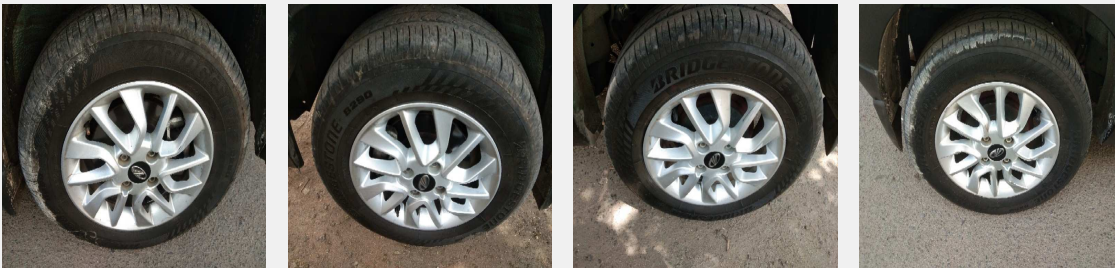
## IMAGES

INSPECTION CHECKPOINTS	SCORE(X/10)	REMARKS/COMMENTS	OPTIONAL SPEND EST. (RS)
TYRES	9	OK	0
SPARE TYRE (YES)	10	OK	0
WHEEL ASSEMBLY (ALLOY RIM)	9	OK	0

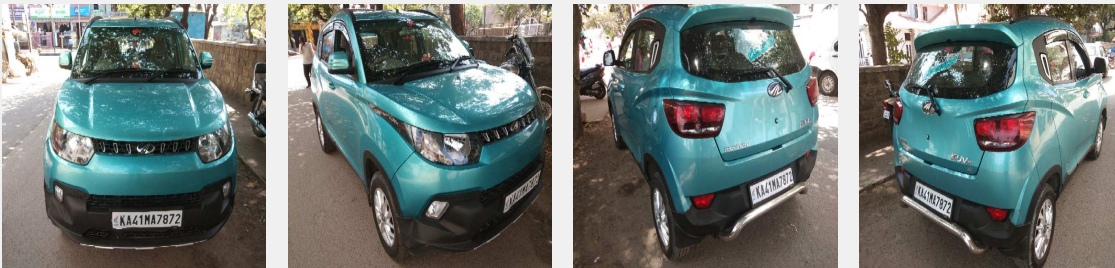
## IMAGES

INSPECTION CHECKPOINTS	SCORE(X/10)	REMARKS/COMMENTS	OPTIONAL SPEND EST. (RS)
RH FRONT DOOR	9	OK	0
RH FENDER	8	PAINTING	2500
BODY RUST	9	OK	0
ROOF (REGULAR)	9	OK	0
PAINT CONDITION	9	OK	0
