ECO INSPECTION CERTIFICATE

Order ID : 42010

121 Points Vehicle Inspection Certificate

Maruti Suzuki 800 AC, 2008

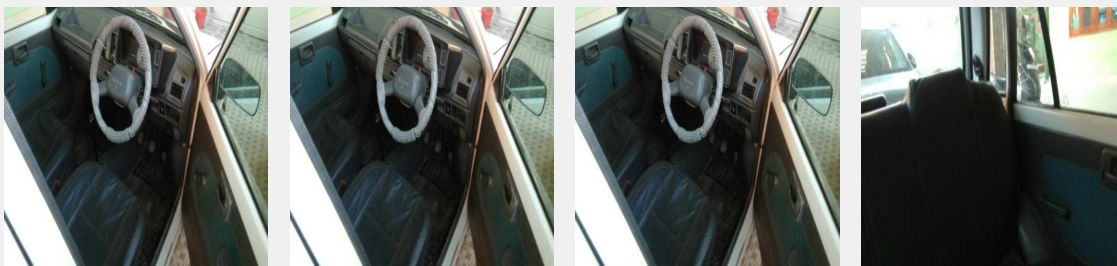
IMAGES

INSPECTION CHECKPOINTS	SCORE(X/10)	REMARKS/COMMENTS	OPTIONAL SPEND EST. (RS)
DOOR PANEL	6	OK	0
DOOR HINGES	6	OK	0
CARPET & FLOOR MAT	7	OK	0
SEAT & SEAT BELT	6	OK	0
DASHBOARD & INSTRUMENT PANEL	6	OK	0
HORN	7	OK	0
SPEAKERS & MUSIC SYSTEM	6	OK	0
HANDBRAKE	7	OK	0
STEERING-MOUNTED CONTROLS	6	OK	0
CENTRAL LOCK	6	OK	0
A/C VENTS & HEATER	6	OK	0
CUP HOLDERS	7	OK	0
NAVIGATION (NO)	10		0
POWER WINDOWS (NO)	10		0
HAZARD LIGHT	6	OK	0
PEDALS	5	OK	0
ODOMETER	5	OK	0

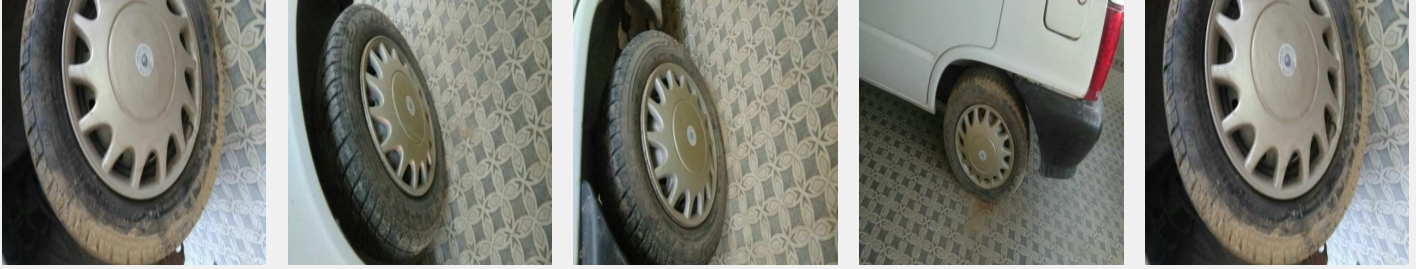
IMAGES

INSPECTION CHECKPOINTS	SCORE(X/10)	REMARKS/COMMENTS	OPTIONAL SPEND EST. (RS)
SPARE TYRE (NO)	10		0
WHEEL ASSEMBLY (ALLOY RIM)	6	OK	0
TYRES	5	OK	0
