# ECO INSPECTION CERTIFICATE

Order ID : 49351

121 Points Vehicle Inspection Certificate

## Skoda Rapid 1.5 TDI CR ELEGANCE, 2012

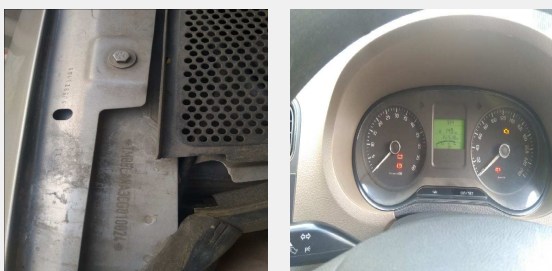
## TEST DRIVE

INSPECTION CHECKPOINTS	SCORE(X/10)	REMARKS/COMMENTS	OPTIONAL SPEND EST. (RS)
STEERING PERFORMANCE	7		0
BRAKE PERFORMANCE	7		0
CLUTCH PERFORMANCE	7		0
ENGINE NOISE	7		0
IGNITION SYSTEM	7		0
SUSPENSION PERFORMANCE	7		0
SUSPENSION FRONT SHOCKS	7		0
SUSPENSION REAR SHOCKS	7		0
TRANSMISSION ENGAGE	7		0
CRUISE CONTROL (NO)	10		0
REAR PARKING SENSORS (NO)	10		0
REAR VIEW CAMERA (NO)	10		0

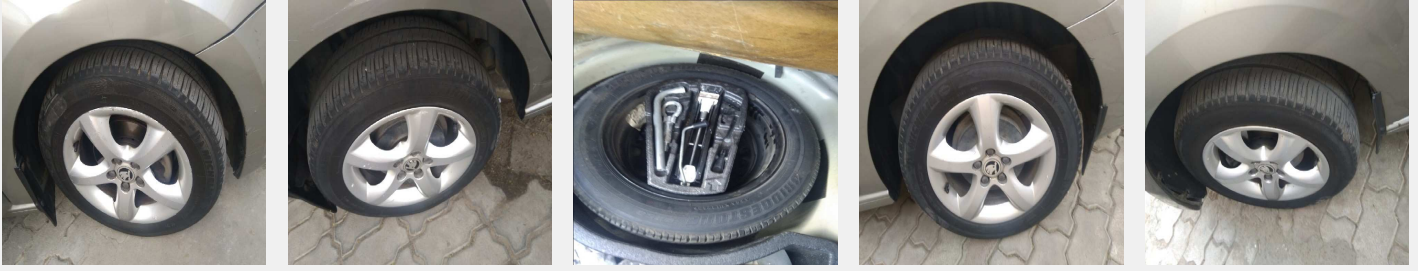
## WHEEL

INSPECTION CHECKPOINTS	SCORE(X/10)	REMARKS/COMMENTS	OPTIONAL SPEND EST. (RS)
TYRES	7		0
SPARE TYRE (YES)	7		0
WHEEL ASSEMBLY (ALLOY RIM)	7		0

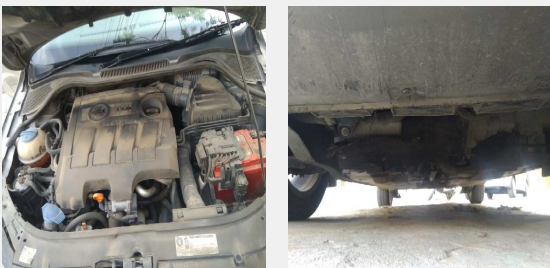
HOOD

INSPECTION CHECKPOINTS	SCORE(X/10)	REMARKS/COMMENTS	OPTIONAL SPEND EST. (RS)
LH APRON	7		0
RH APRON	7		0
RADIATOR	7		0
WIRING	7		0
BATTERY	7		0
BRAKE FLUID LEVEL	7		0
ENGINE OIL	7		0
COOLANT LEVEL	7		0
BRAKE & COOLANT HOSE PIPES	7		0
UNDERCARRIAGE	7		0
EXHAUST SYSTEM	7		0
