ECO INSPECTION CERTIFICATE

Order ID : 46521

121 Points Vehicle Inspection Certificate

Maruti Suzuki Swift VDI, 2012

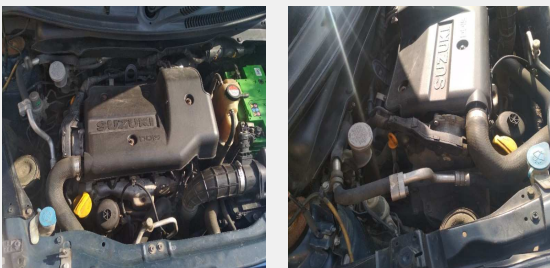
HOOD

INSPECTION CHECKPOINTS	SCORE(X/10)	REMARKS/COMMENTS	OPTIONAL SPEND EST. (RS)
LH APRON	10		0
RH APRON	10		0
RADIATOR	10		0
WIRING	10		0
BATTERY	10		0
BRAKE FLUID LEVEL	10		0
ENGINE OIL	10		0
COOLANT LEVEL	10		0
BRAKE & COOLANT HOSE PIPES	10		0
UNDERCARRIAGE	10		0
EXHAUST SYSTEM	10		0
