ECO INSPECTION CERTIFICATE

Order ID : 51078

121 Points Vehicle Inspection Certificate

Maruti Suzuki Swift VDI, 2016

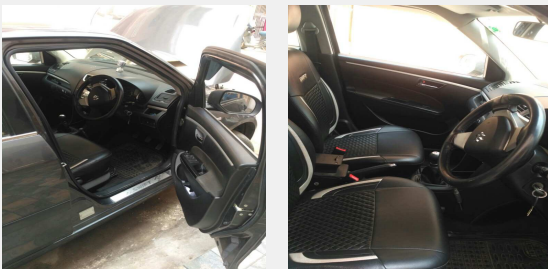
IMAGES

INSPECTION CHECKPOINTS	SCORE(X/10)	REMARKS/COMMENTS	OPTIONAL SPEND EST. (RS)
DOOR PANEL	7	GOOD CONDITION	0
DOOR HINGES	7	GOOD CONDITION	0
CARPET & FLOOR MAT	7	GOOD CONDITION	0
SEAT & SEAT BELT	7	GOOD CONDITION	0
DASHBOARD & INSTRUMENT PANEL	7	GOOD CONDITION	0
HORN	7	GOOD SOUND	0
SPEAKERS & MUSIC SYSTEM	7	GOOD MUSIC	0
HANDBRAKE	7	GOOD CONDITION	0
PEDALS	7	GOOD CONDITION	0
CENTRAL LOCK	7	GOOD CONDITION	0
A/C VENTS & HEATER	7	GOOD COOLING	0
CUP HOLDERS	7	GOOD CONDITION	0
ODOMETER	7	GOOD CONDITION	0
POWER WINDOWS (YES)	7	GOOD CONDITION	0
HAZARD LIGHT	7	GOOD CONDITION	0
STEERING-MOUNTED CONTROLS	0	NA	0
NAVIGATION (YES)	0	NA	0

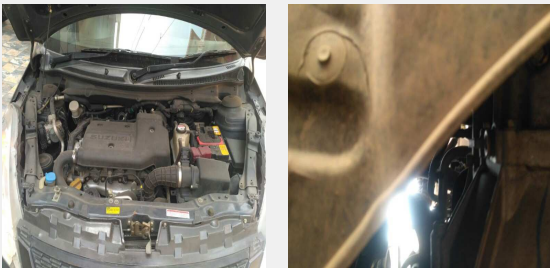
IMAGES

INSPECTION CHECKPOINTS	SCORE(X/10)	REMARKS/COMMENTS	OPTIONAL SPEND EST. (RS)
LH APRON	7	GOOD CONDITION	0
RH APRON	7	GOOD CONDITION	0
RADIATOR	7	GOOD CONDITION	0
WIRING	7	GOOD CONDITION	0
BATTERY	7	GOOD CONDITION	0
BRAKE FLUID LEVEL	7	GOOD CONDITION	0
ENGINE OIL	7	GOOD VISCOSITY	0
COOLANT LEVEL	7	MAXIMUM LEVEL	0
BRAKE & COOLANT HOSE PIPES	7	GOOD CONDITION	0
UNDERCARRIAGE	7	GOOD CONDITION	0
EXHAUST SYSTEM	7	GOOD CONDITION	0
