ECO INSPECTION CERTIFICATE

121 Points Vehicle Inspection Certificate

Mitsubishi Lancer LXI 1.5, 2004

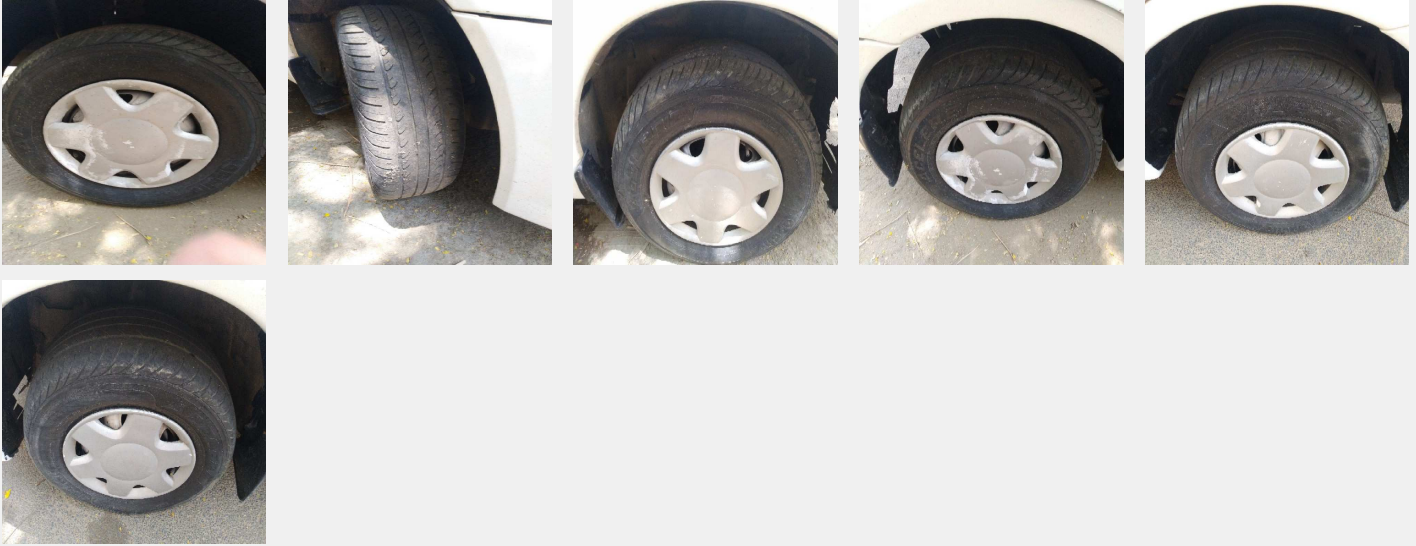
INSPECTION CHECKPOINTS	SCORE(X/10)	REMARKS/COMMENTS	OPTIONAL SPEND EST. (RS)
TYRES	6		0
SPARE TYRE (NO)	10		0
WHEEL ASSEMBLY (ALLOY RIM)	6		0

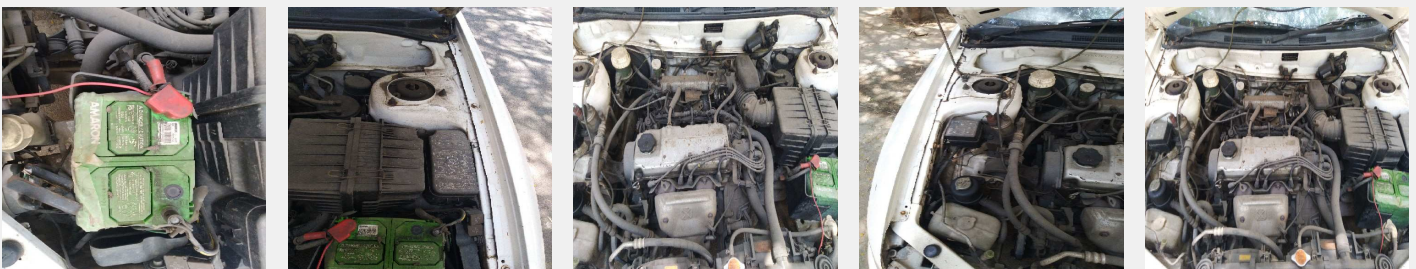
HOOD

INSPECTION CHECKPOINTS	SCORE(X/10)	REMARKS/COMMENTS	OPTIONAL SPEND EST. (RS)
LH APRON	6		0
RH APRON	6		0
RADIATOR	6		0
WIRING	6		0
BATTERY	6		0
BRAKE FLUID LEVEL	6		0
ENGINE OIL	6		0
COOLANT LEVEL	6		0
BRAKE & COOLANT HOSE PIPES	6		0
UNDERCARRIAGE	6		0
EXHAUST SYSTEM	6		0
