ECO INSPECTION CERTIFICATE

121 Points Vehicle Inspection Certificate

Ordered By : Roahan	Inspection Date : 2019-04-27	Location : INDRANAGAR	Inspected By

Maruti Suzuki Eeco 5 STR AC, 2011

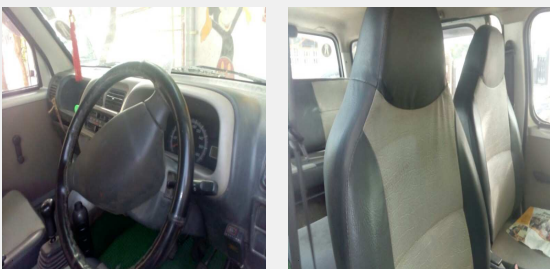
INTERIOR

INSPECTION CHECKPOINTS	SCORE(X/10)	REMARKS/COMMENTS	OPTIONAL SPEND EST. (RS)
DOOR PANEL	6		0
DOOR HINGES	6		0
CARPET & FLOOR MAT	6		0
SEAT & SEAT BELT	6		0
DASHBOARD & INSTRUMENT PANEL	6		0
HORN	6		0
SPEAKERS & MUSIC SYSTEM	6		0
HANDBRAKE	6		0
STEERING-MOUNTED CONTROLS	6		0
PEDALS	6		0
CENTRAL LOCK	6		0
A/C VENTS & HEATER	6		0
CUP HOLDERS	6		0
NAVIGATION (NO)	10		0
ODOMETER	6		0
POWER WINDOWS (NO)	10		0
HAZARD LIGHT	6		0

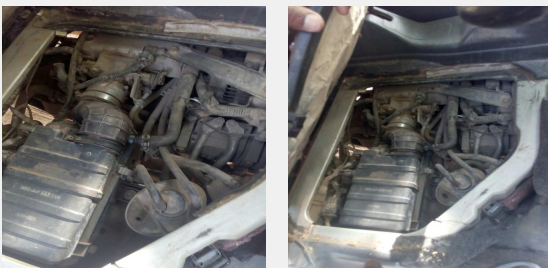
HOOD

INSPECTION CHECKPOINTS	SCORE(X/10)	REMARKS/COMMENTS	OPTIONAL SPEND EST. (RS)
LH APRON	6		0
RH APRON	6		0
RADIATOR	6		0
WIRING	6		0
BATTERY	6		0
BRAKE FLUID LEVEL	6		0
ENGINE OIL	6		0
COOLANT LEVEL	6		0
BRAKE & COOLANT HOSE PIPES	6		0
UNDERCARRIAGE	6		0
EXHAUST SYSTEM	6		0
