ECO INSPECTION CERTIFICATE

Order ID : 63040

121 Points Vehicle Inspection Certificate

Maruti Suzuki Swift Vdi , 2010

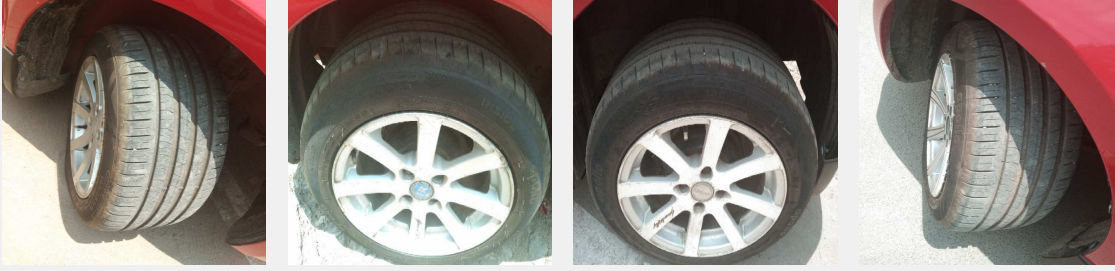
INSPECTION CHECKPOINTS	SCORE(X/10)	REMARKS/COMMENTS	OPTIONAL SPEND EST. (RS)
TYRES	7	GOOD	0
SPARE TYRE (NO)	10		0
WHEEL ASSEMBLY (ALLOY RIM)	7	GOOD	0

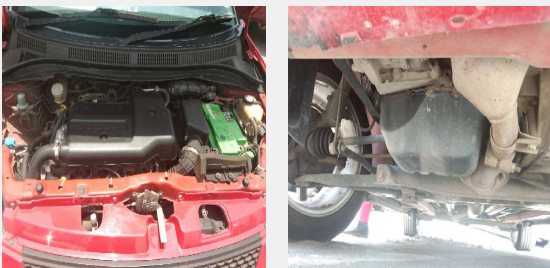
HOOD

INSPECTION CHECKPOINTS	SCORE(X/10)	REMARKS/COMMENTS	OPTIONAL SPEND EST. (RS)
LH APRON	7	GOOD	0
RH APRON	7	GOOD	0
RADIATOR	7	GOOD	0
WIRING	7	GOOD	0
BATTERY	7	GOOD	0
BRAKE FLUID LEVEL	7	GOOD	0
ENGINE OIL	7	GOOD	0
COOLANT LEVEL	7	GOOD	0
BRAKE & COOLANT HOSE PIPES	7	GOOD	0
UNDERCARRIAGE	7	GOOD	0
EXHAUST SYSTEM	7	GOOD	0
