ECO INSPECTION CERTIFICATE

121 Points Vehicle Inspection Certificate

Ordered By : Ajay Radadiya	Inspection Date : 2019-05-09	Location : SURAT

Honda Amaze 1.5 S I-DTEC, 2015

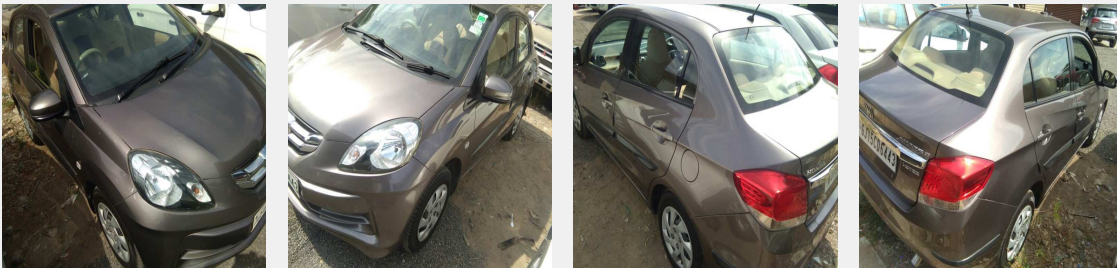
INSPECTION CHECKPOINTS	SCORE(X/10)	REMARKS/COMMENTS	OPTIONAL SPEND EST. (RS)
RH FRONT DOOR	7		0
RH FENDER	7		0
BODY RUST	6		0
ROOF (REGULAR)	6		0
PAINT CONDITION	7		0
