ECO INSPECTION CERTIFICATE

121 Points Vehicle Inspection Certificate

Ordered By : Anshul Chawla	Inspection Date : 2019-05-16	Location : GHAZIABAD
--------------------------------------	--	--------------------------------

Toyota Fortuner 3.0 4X2 MT, 2015

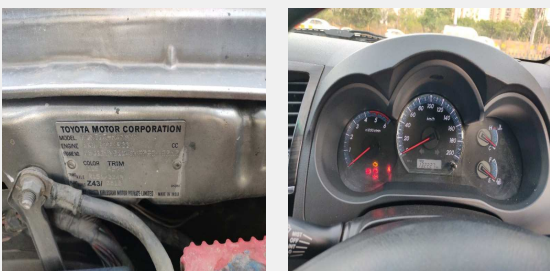
IMAGES

INSPECTION CHECKPOINTS	SCORE(X/10)	REMARKS/COMMENTS	OPTIONAL SPEND EST. (RS)
STEERING PERFORMANCE	7		0
BRAKE PERFORMANCE	7		0
CLUTCH PERFORMANCE	7		0
ENGINE NOISE	7		0
IGNITION SYSTEM	7		0
SUSPENSION PERFORMANCE	7		0
SUSPENSION FRONT SHOCKS	7		0
SUSPENSION REAR SHOCKS	7		0
TRANSMISSION ENGAGE	7		0
REAR VIEW CAMERA (YES)	7		0
CRUISE CONTROL (YES)	0	NA	0
REAR PARKING SENSORS (YES)	0	NA	0

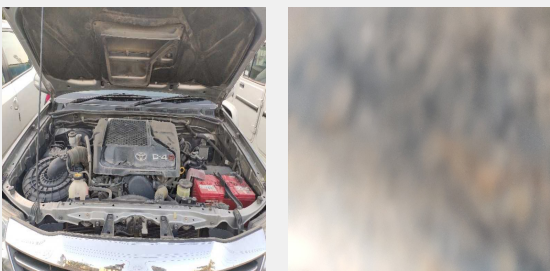
IMAGES

INSPECTION CHECKPOINTS	SCORE(X/10)	REMARKS/COMMENTS	OPTIONAL SPEND EST. (RS)
LH APRON	7		0
RH APRON	7		0
RADIATOR	7		0
WIRING	7		0
BATTERY	7		0
BRAKE FLUID LEVEL	7		0
ENGINE OIL	7		0
COOLANT LEVEL	7		0
BRAKE & COOLANT HOSE PIPES	7		0
UNDERCARRIAGE	7		0
EXHAUST SYSTEM	7		0

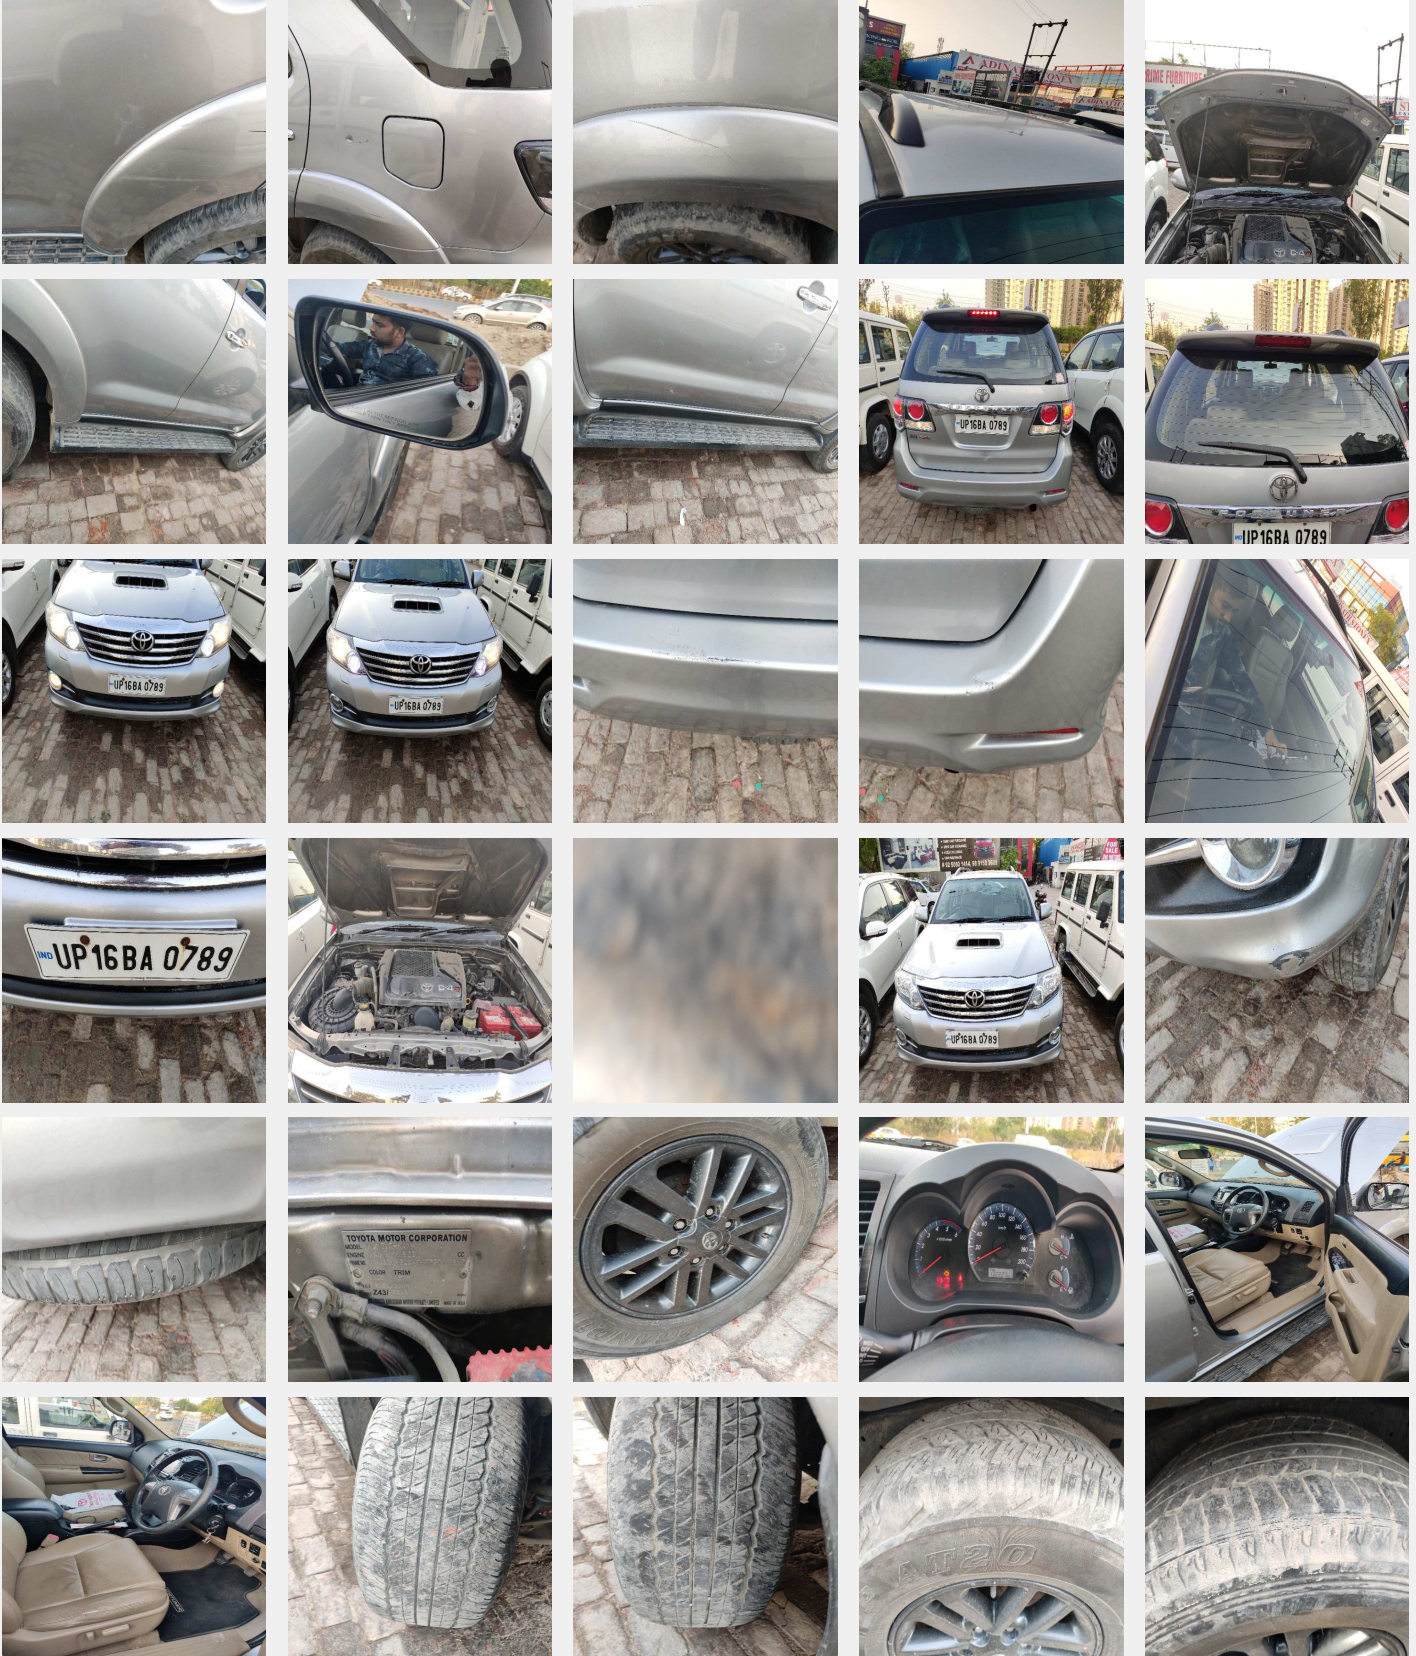
IMAGES

all body minor scratches and tyres worn out
