ECO INSPECTION CERTIFICATE

121 Points Vehicle Inspection Certificate

Ordered By : Tarun	Inspection Date : 2019-05-18	Location : PHASE 3
-----------------------	---------------------------------	-----------------------

Maruti Suzuki Swift Dzire VDI, 2011

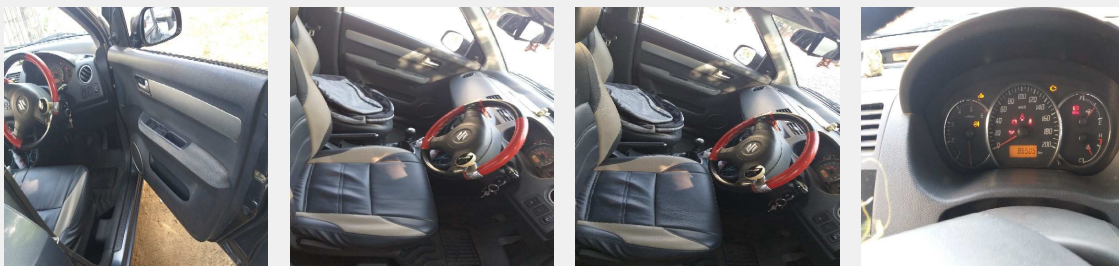
INTERIOR

INSPECTION CHECKPOINTS	SCORE(X/10)	REMARKS/COMMENTS	OPTIONAL SPEND EST. (RS)
DOOR PANEL	7	GOOD	0
DOOR HINGES	7	GOOD	0
CARPET & FLOOR MAT	7	GOOD	0
SEAT & SEAT BELT	7	GOOD	0
DASHBOARD & INSTRUMENT PANEL	7	GOOD	0
HORN	7	GOOD	0
SPEAKERS & MUSIC SYSTEM	7	GOOD	0
HANDBRAKE	7	GOOD	0
PEDALS	7	GOOD	0
CENTRAL LOCK	7	GOOD	0
A/C VENTS & HEATER	7	GOOD	0
CUP HOLDERS	7	GOOD	0
NAVIGATION (NO)	10		0
ODOMETER	7	GOOD	0
POWER WINDOWS (YES)	7	GOOD	0
HAZARD LIGHT	7	GOOD	0
STEERING-MOUNTED CONTROLS	0	NOT AVAILABLE	0

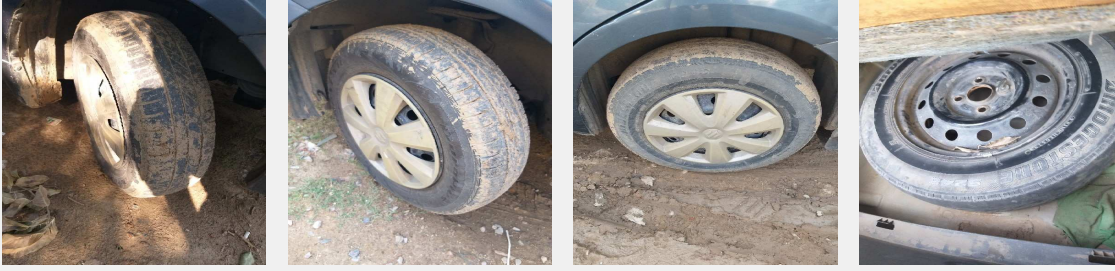
INSPECTION CHECKPOINTS	SCORE(X/10)	REMARKS/COMMENTS	OPTIONAL SPEND EST. (RS)
TYRES	7	GOOD	0
SPARE TYRE (YES)	7	GOOD	0
WHEEL ASSEMBLY (STEEL RIM)	7	GOOD	0

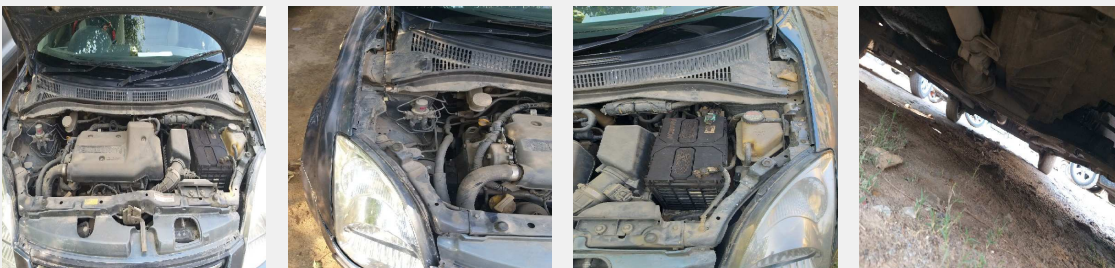
HOOD

INSPECTION CHECKPOINTS	SCORE(X/10)	REMARKS/COMMENTS	OPTIONAL SPEND EST. (RS)
LH APRON	7	GOOD	0
RH APRON	7	GOOD	0
RADIATOR	7	GOOD	0
WIRING	7	GOOD	0
BATTERY	7	GOOD	0
BRAKE FLUID LEVEL	7	MAXIMUM	0
ENGINE OIL	7	MAXIMUM	0
COOLANT LEVEL	7	MAXIMUM	0
BRAKE & COOLANT HOSE PIPES	7	GOOD	0
UNDERCARRIAGE	7	GOOD	0
EXHAUST SYSTEM	7	GOOD	0
