ECO INSPECTION CERTIFICATE

121 Points Vehicle Inspection Certificate

| Ordered By : Aman Gajwani | Inspection Date : 2019-05-22 | Location : GHAZIABAD | Inspected By Kishan Kumar |

Maruti Suzuki Alto 800 Lxi, 2016

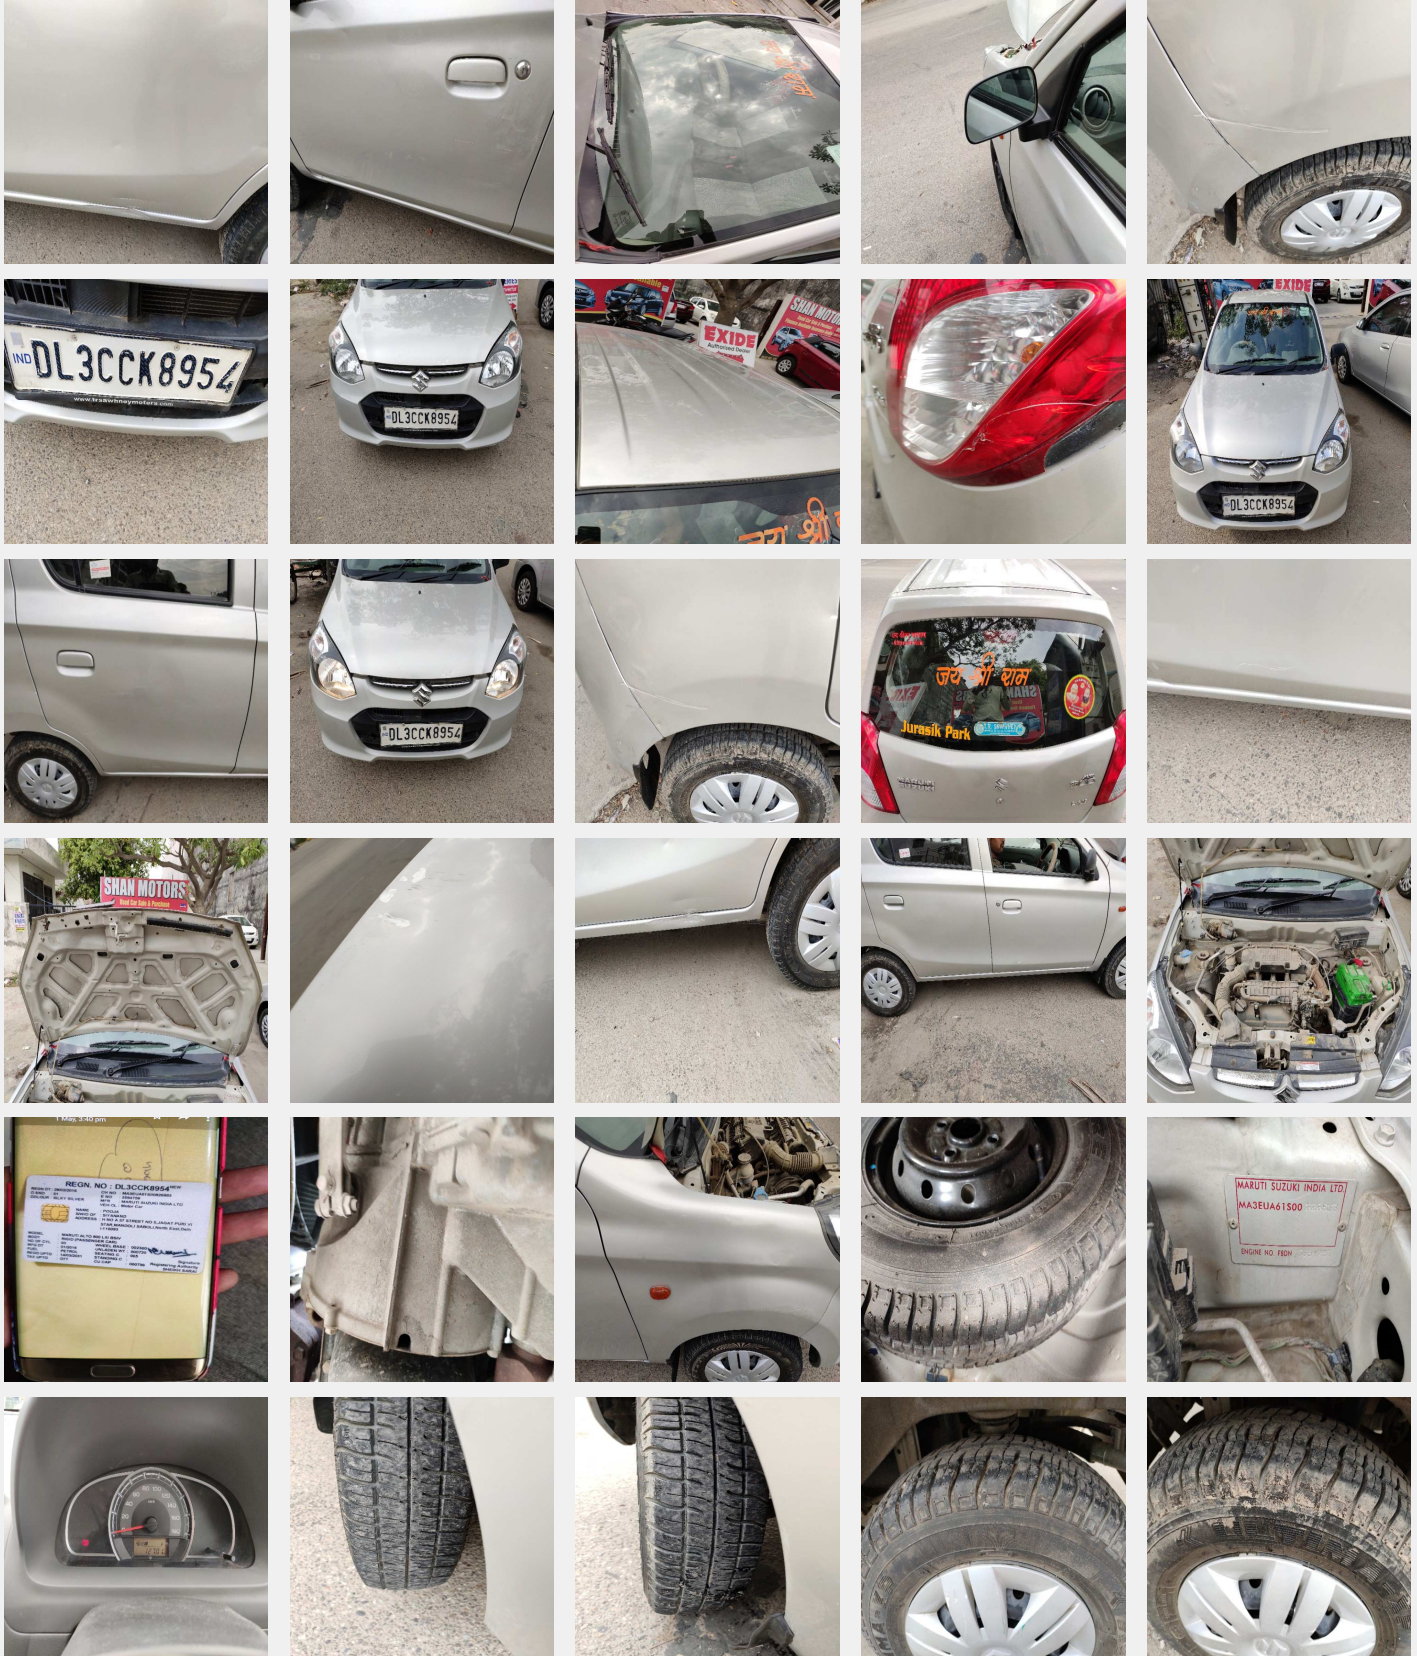
| INSPECTION CHECKPOINTS | SCORE(X/10) | REMARKS/COMMENTS | OPTIONAL SPEND EST. (RS) |
|---|---|--|---|
| LH RUNNING BOARD | 5 | DENT AND SCRATCHES NEED TO BE REPAIR | 600 |
| TAIL LIGHT | 5 | RIGHT TAIL LIGHT BROKEN NEED TO CHANGE | 1000 |

all body scratches and dent need to be repair and right side tail light broken need to change
