ECO INSPECTION CERTIFICATE

Order ID : 71594

121 Points Vehicle Inspection Certificate

Maruti Suzuki Alto LXI, 2009

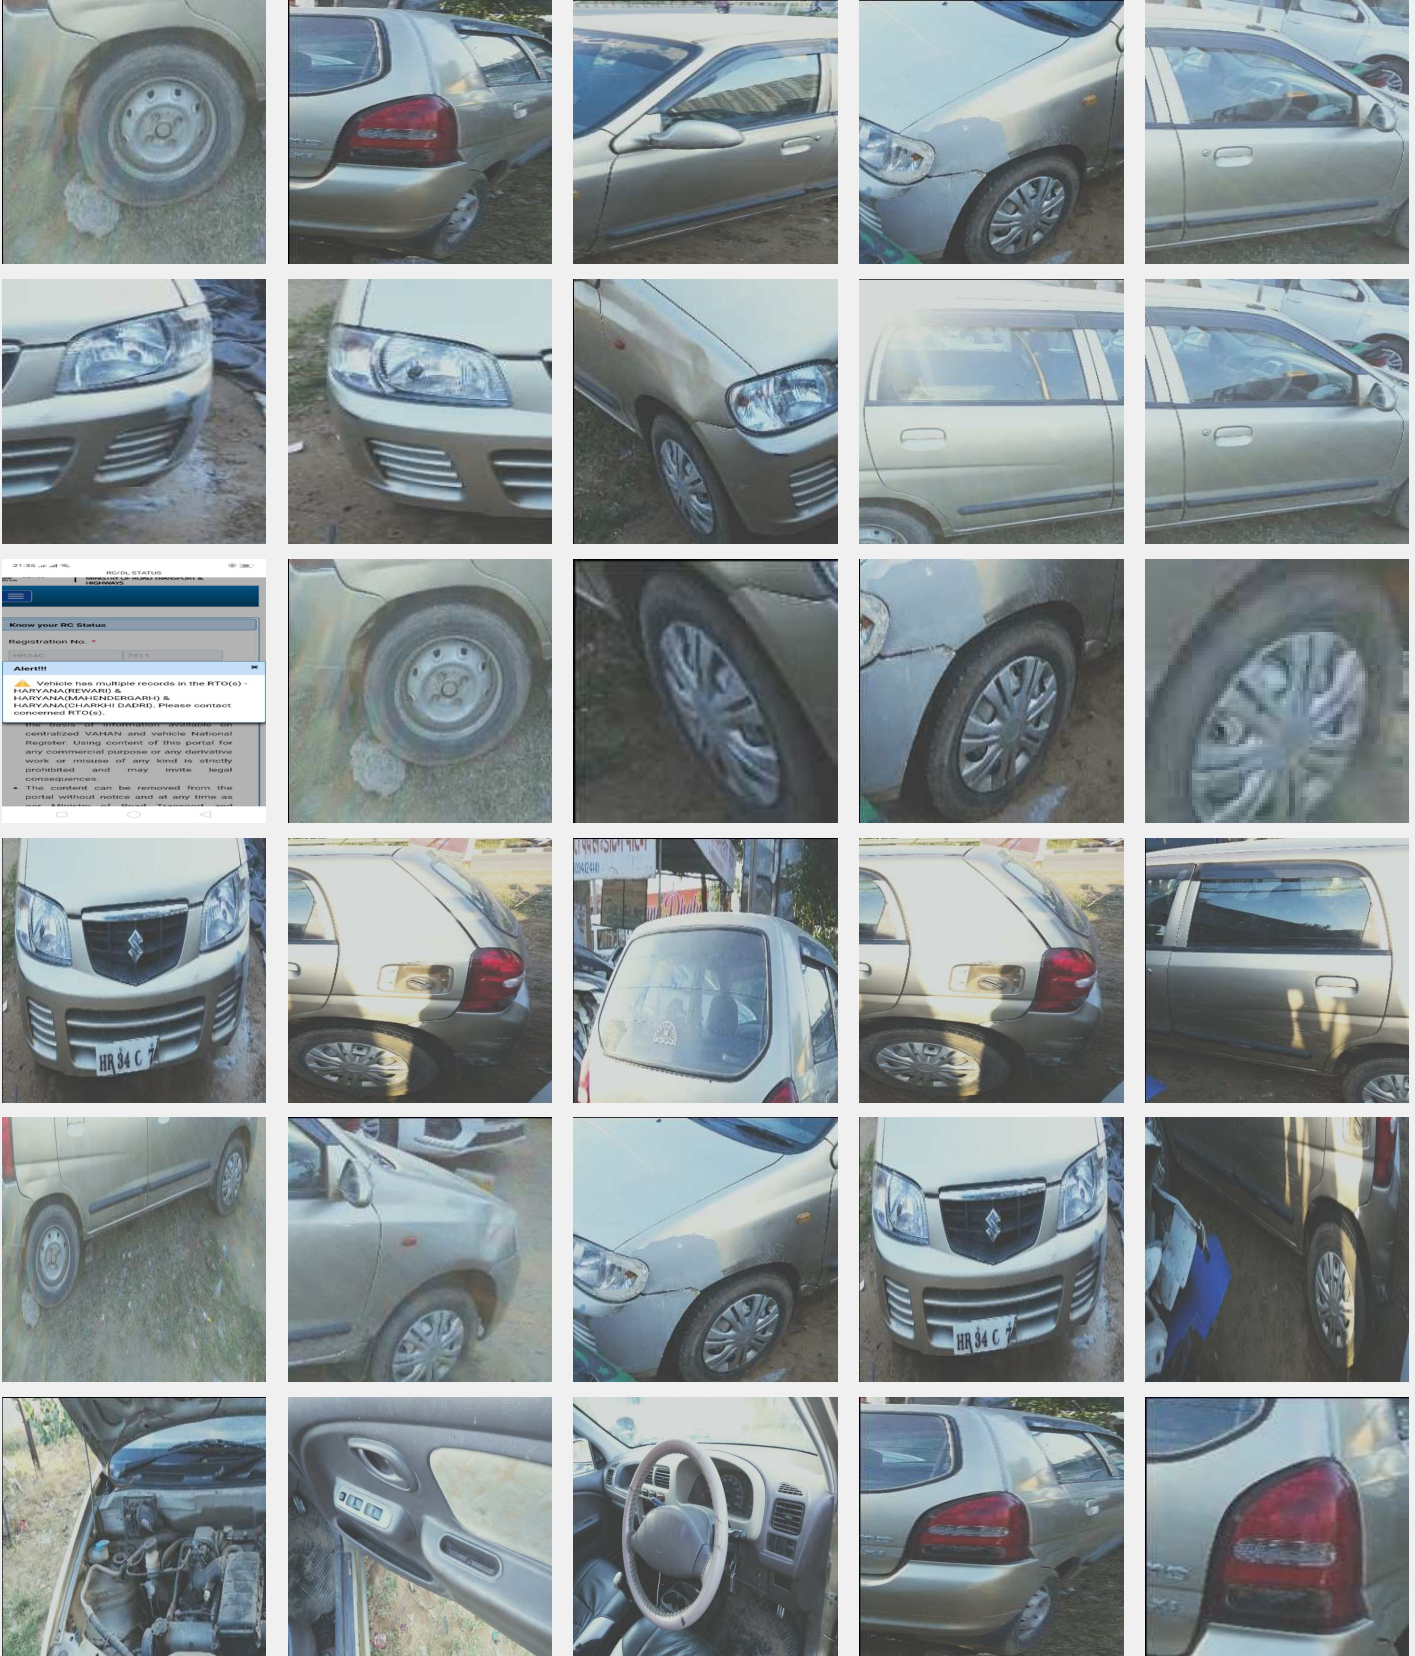
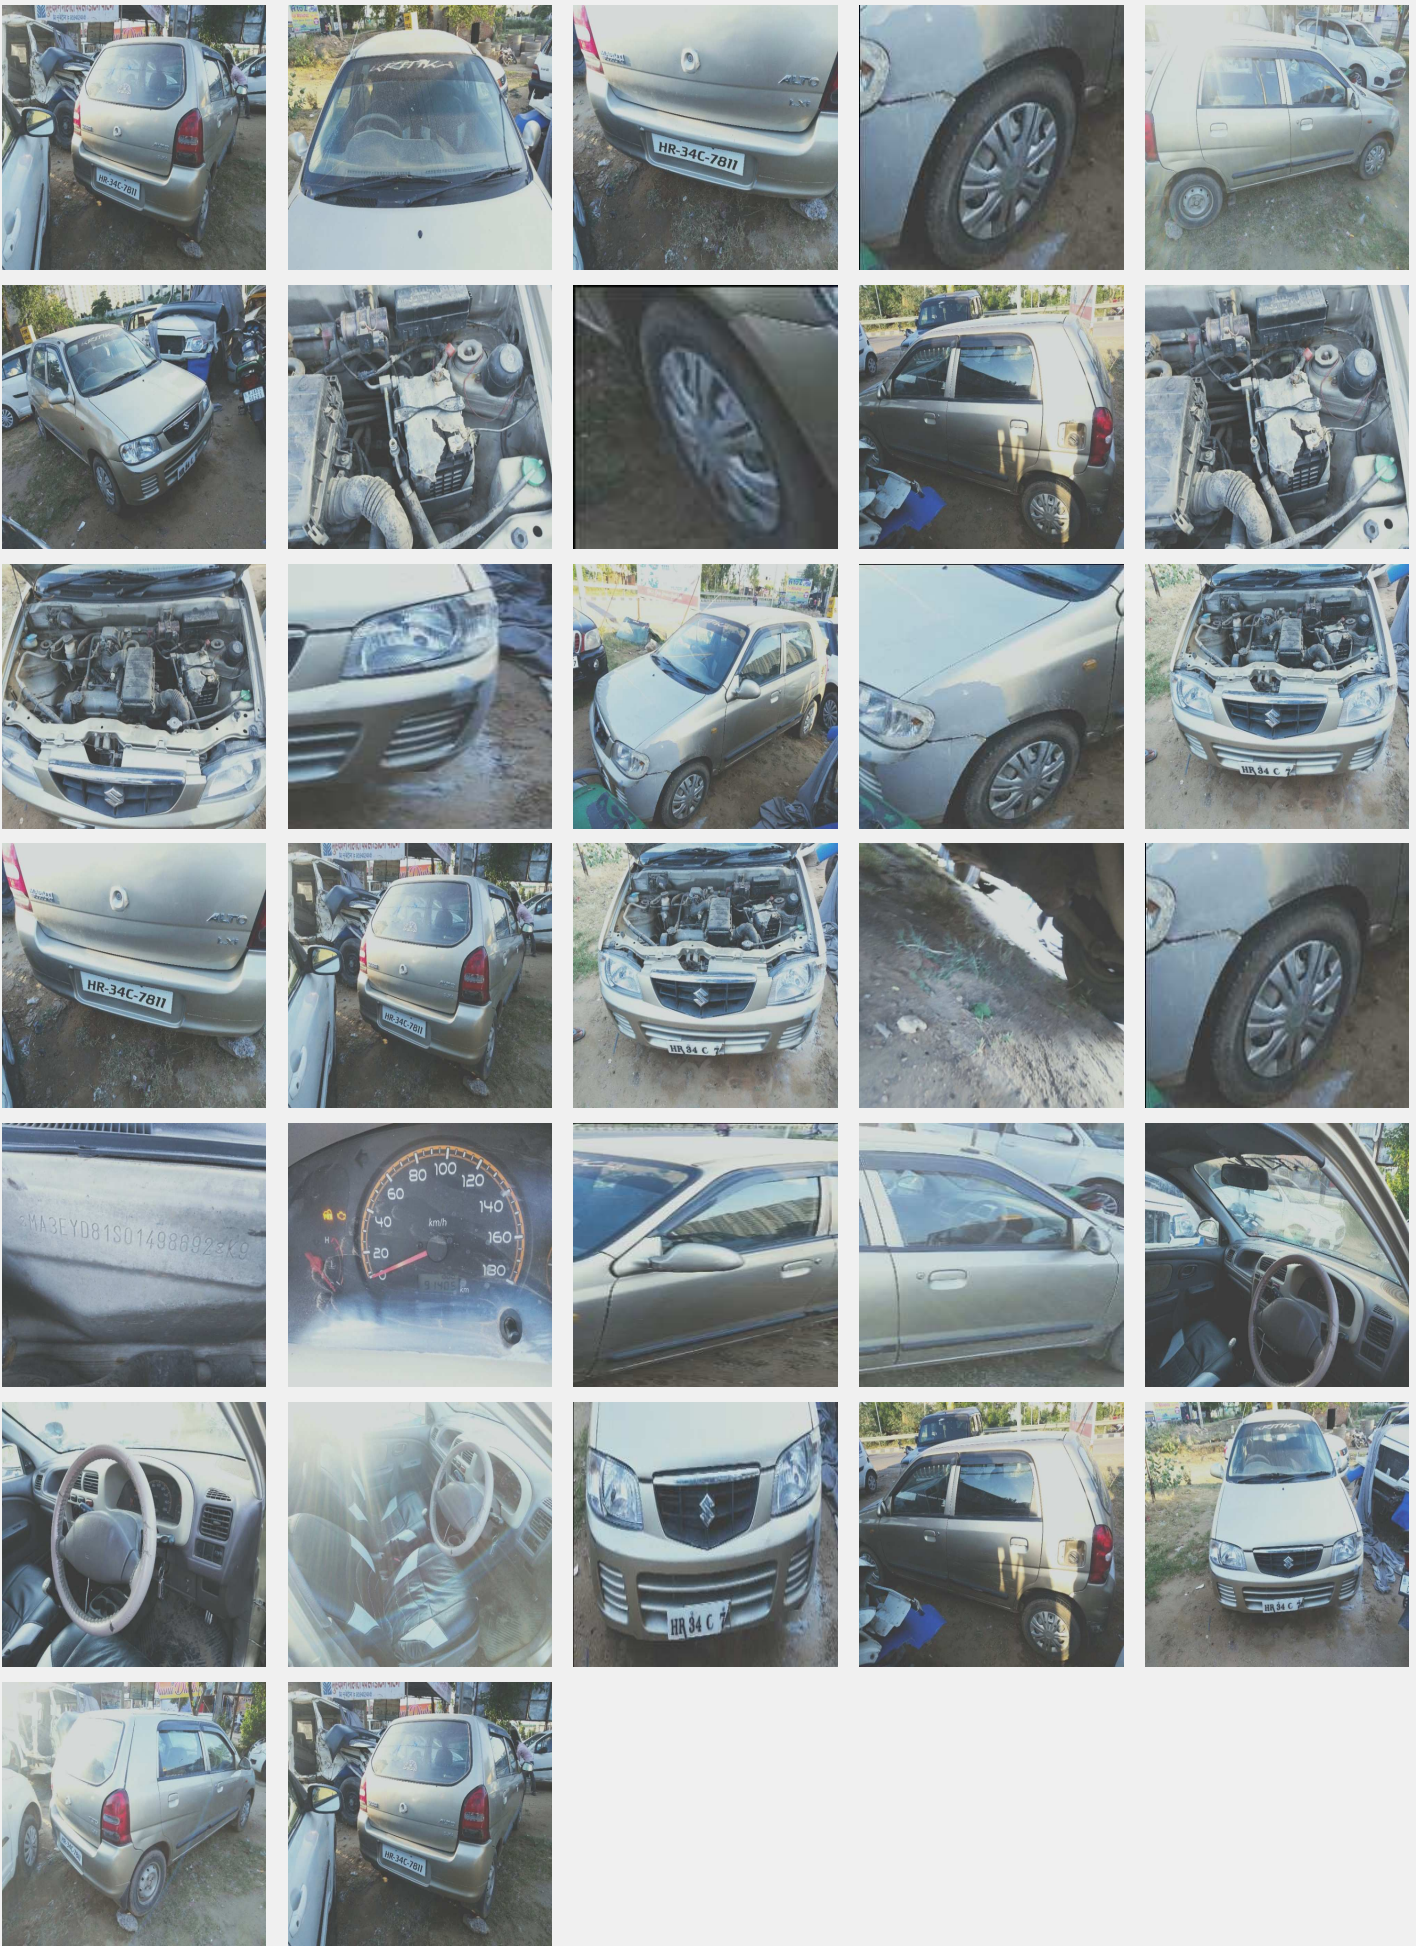
IMAGES

| INSPECTION CHECKPOINTS | SCORE(X/10) | REMARKS/COMMENTS | OPTIONAL SPEND EST. (RS) |
|---|---|---|---|
| LICENSE PLATE | 1 | BROKEN | 1000 |
| FUEL LID | 2 | DOOR MISSING | 4000 |
| PAINT CONDITION | 4 | FAIR | 10000 |
