# ECO INSPECTION CERTIFICATE

121 Points Vehicle Inspection Certificate

Ordered By : Anshul Chawla	Inspection Date : 2019-05-24	Location : GHAZIABAD	Inspected By  Kishan Kumar
-------------------------------	---------------------------------	-------------------------	----------------------------------

## Toyota Innova Crysta 2.8 Z 7 STR AT, 2017

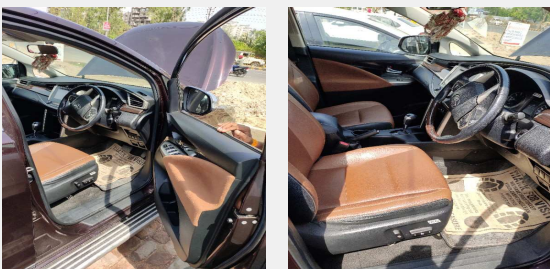
## IMAGES

INSPECTION CHECKPOINTS	SCORE(X/10)	REMARKS/COMMENTS	OPTIONAL SPEND EST. (RS)
DOOR PANEL	8		0
DOOR HINGES	8		0
CARPET & FLOOR MAT	8		0
SEAT & SEAT BELT	8		0
DASHBOARD & INSTRUMENT PANEL	8		0
HORN	8		0
SPEAKERS & MUSIC SYSTEM	8		0
HANDBRAKE	8		0
STEERING-MOUNTED CONTROLS	8		0
PEDALS	8		0
CENTRAL LOCK	8		0
A/C VENTS & HEATER	8		0
CUP HOLDERS	8		0
ODOMETER	8		0
POWER WINDOWS (YES)	8		0
HAZARD LIGHT	8		0
NAVIGATION (YES)	0	NA	0

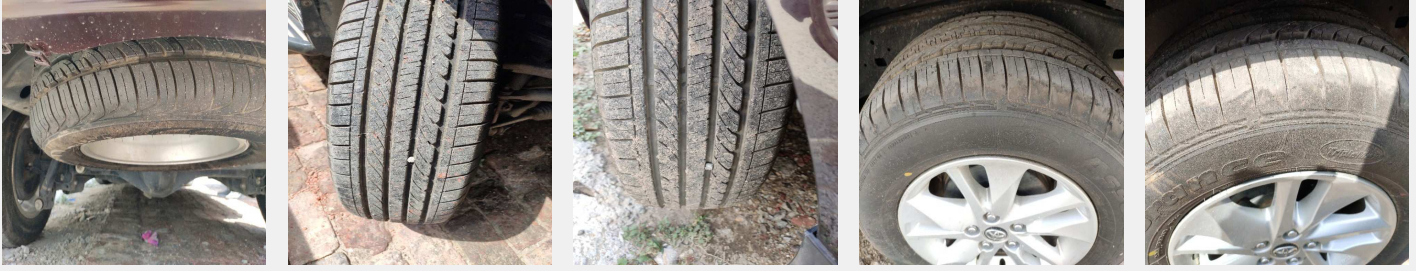
IMAGES

INSPECTION CHECKPOINTS	SCORE(X/10)	REMARKS/COMMENTS	OPTIONAL SPEND EST. (RS)
TYRES	8		0
SPARE TYRE (YES)	9	BRAND NEW	0
WHEEL ASSEMBLY (ALLOY RIM)	8		0

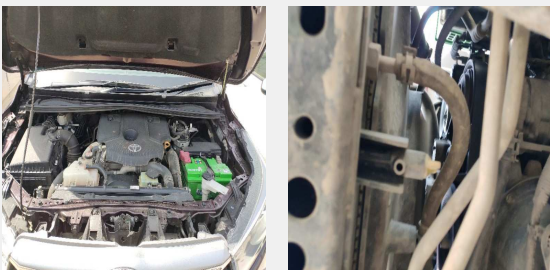
IMAGES

INSPECTION CHECKPOINTS	SCORE(X/10)	REMARKS/COMMENTS	OPTIONAL SPEND EST. (RS)
LH APRON	8		0
RH APRON	8		0
RADIATOR	8		0
WIRING	8		0
BATTERY	8		0
BRAKE FLUID LEVEL	8		0
ENGINE OIL	8		0
COOLANT LEVEL	8		0
BRAKE & COOLANT HOSE PIPES	8		0
UNDERCARRIAGE	8		0
EXHAUST SYSTEM	8		0

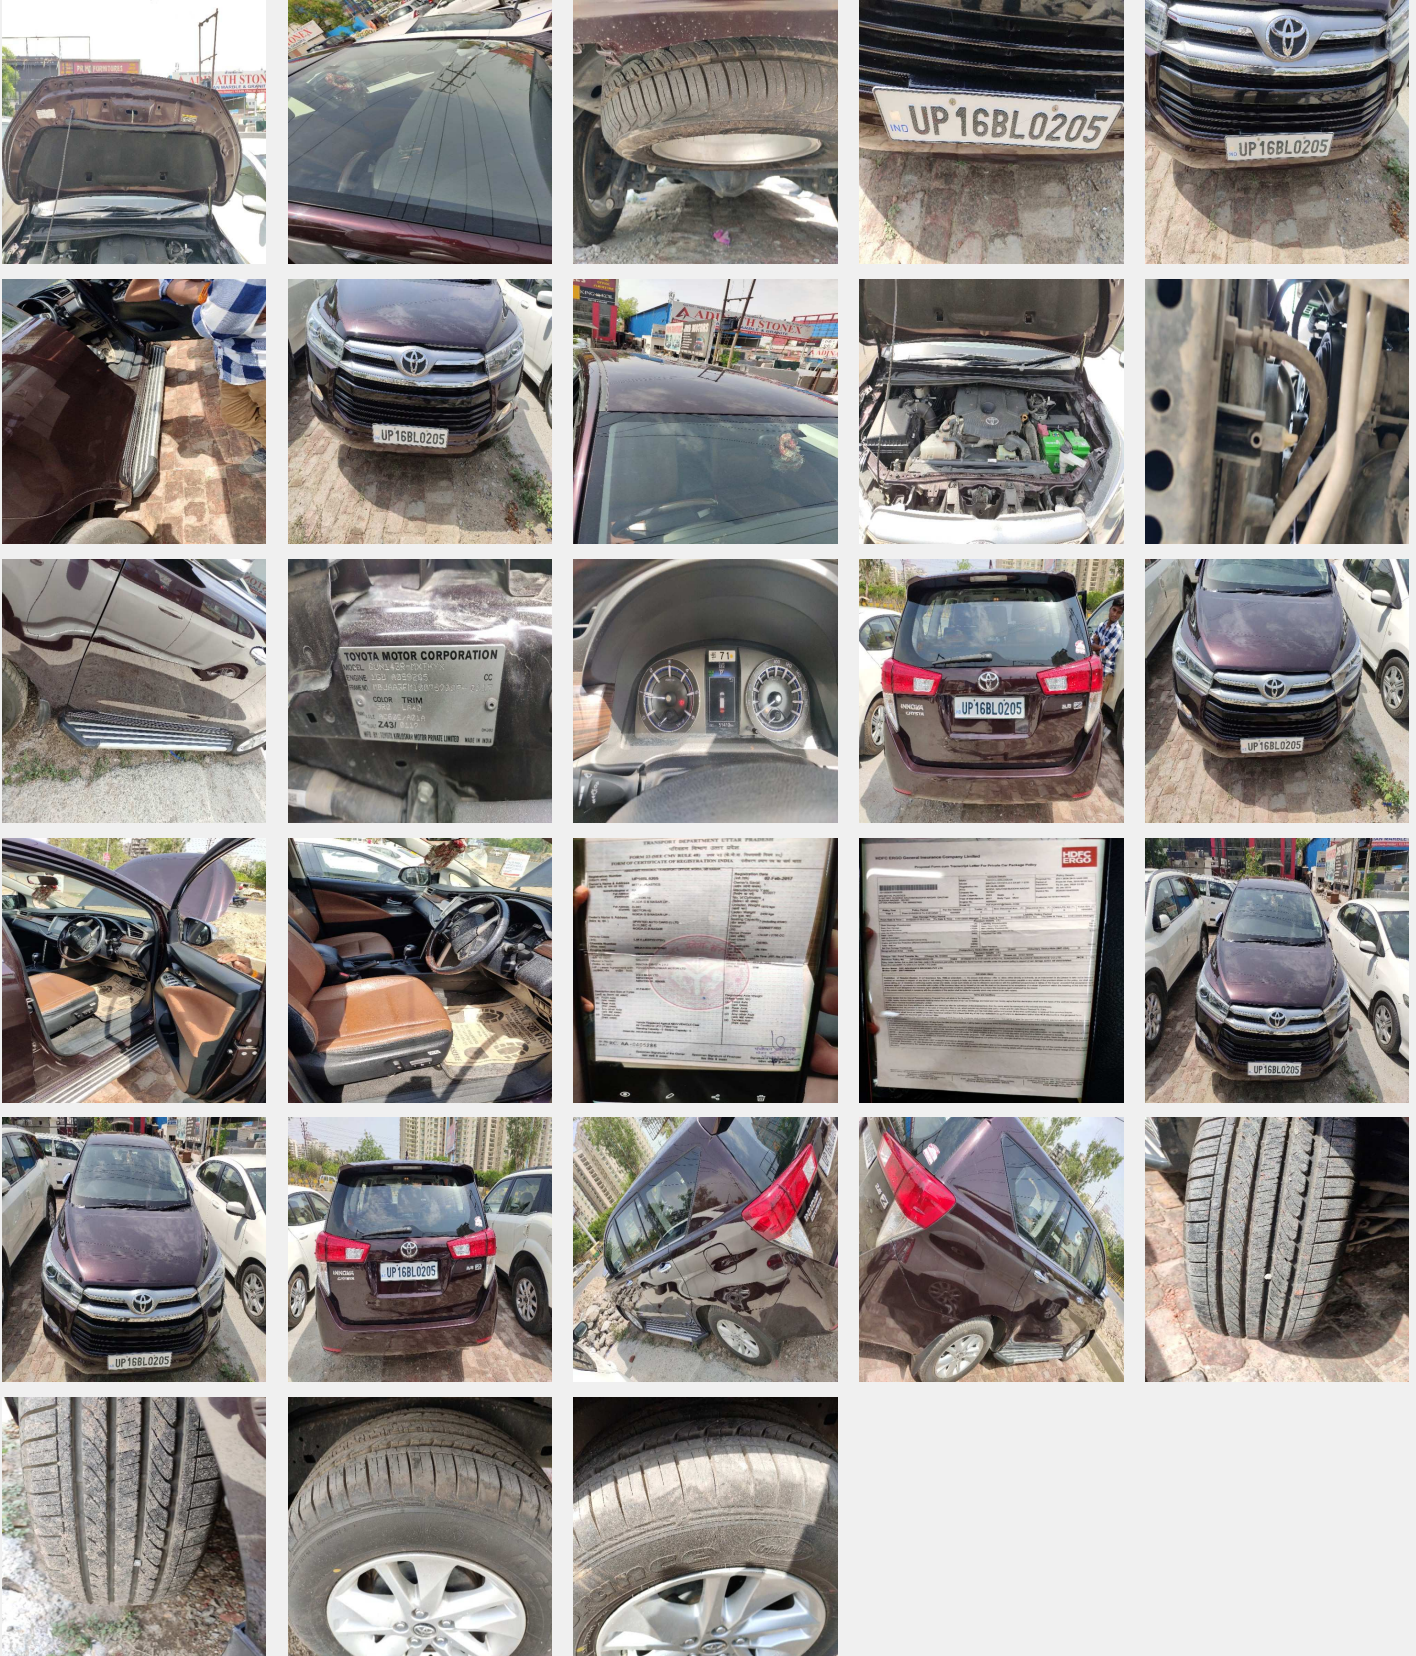
IMAGES

all body minor scratches
