ECO INSPECTION CERTIFICATE

121 Points Vehicle Inspection Certificate

Ordered By : Amit Malhotra	Inspection Date : 2019-05-23	Location : DELHI	Inspected By

Skoda Laura ELEGANCE 2.0 TDI CR MT, 2011

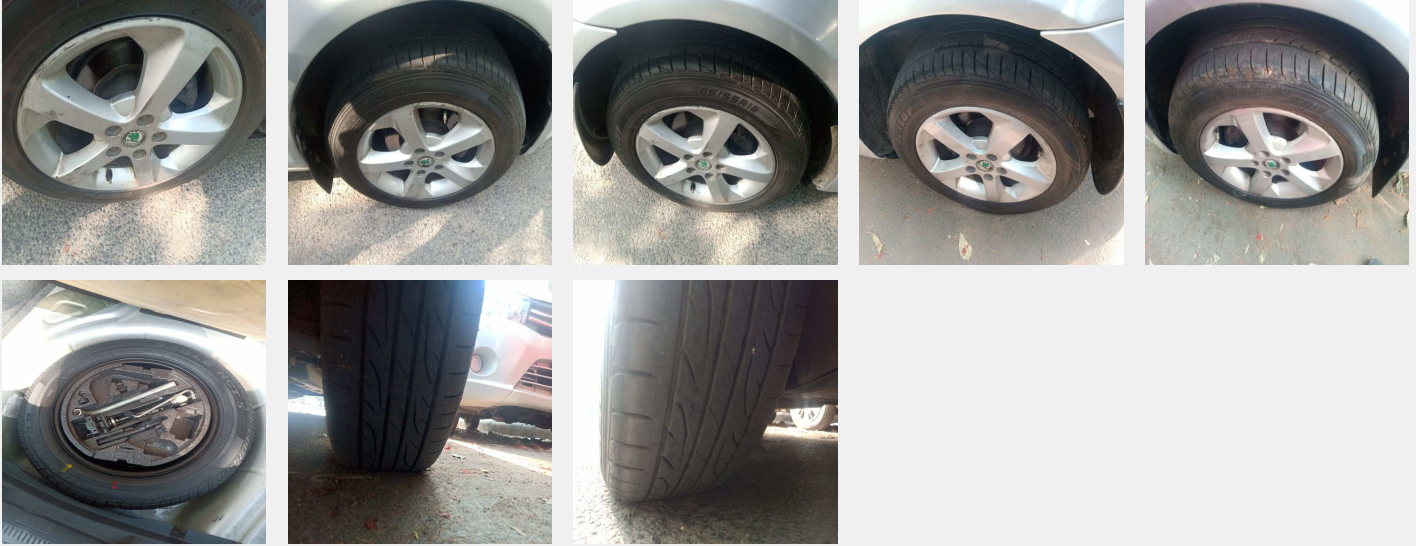
INSPECTION CHECKPOINTS	SCORE(X/10)	REMARKS/COMMENTS	OPTIONAL SPEND EST. (RS)
TYRES	7	GOOD	0
SPARE TYRE (YES)	7	GOOD	0
WHEEL ASSEMBLY (ALLOY RIM)	7	GOOD	0

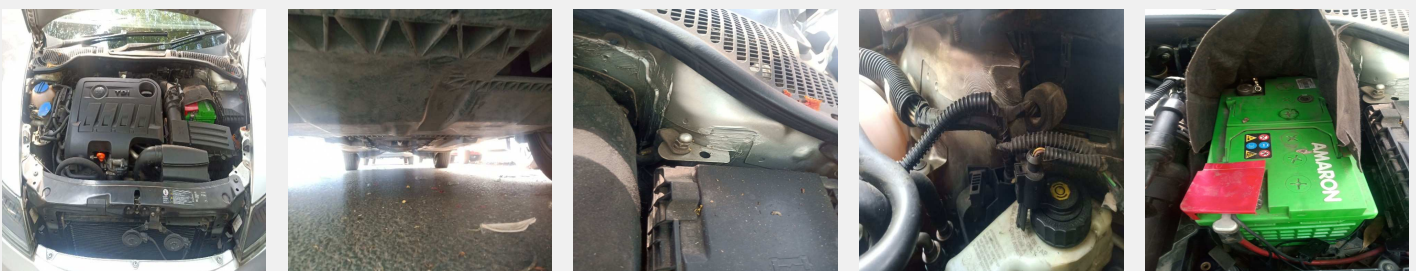
HOOD

INSPECTION CHECKPOINTS	SCORE(X/10)	REMARKS/COMMENTS	OPTIONAL SPEND EST. (RS)
LH APRON	7	GOOD	0
RH APRON	7	GOOD	0
RADIATOR	7	GOOD	0
WIRING	7	GOOD	0
BATTERY	7	GOOD	0
BRAKE FLUID LEVEL	7	MAXIMUM	0
ENGINE OIL	7	MAXIMUM	0
COOLANT LEVEL	7	MAXIMUM	0
BRAKE & COOLANT HOSE PIPES	7	GOOD	0
UNDERCARRIAGE	7	GOOD	0
EXHAUST SYSTEM	7	GOOD	0
