ECO INSPECTION CERTIFICATE

Order ID : 76795

121 Points Vehicle Inspection Certificate

Hyundai I10 Sportz 1.2 Kappa2, 2011

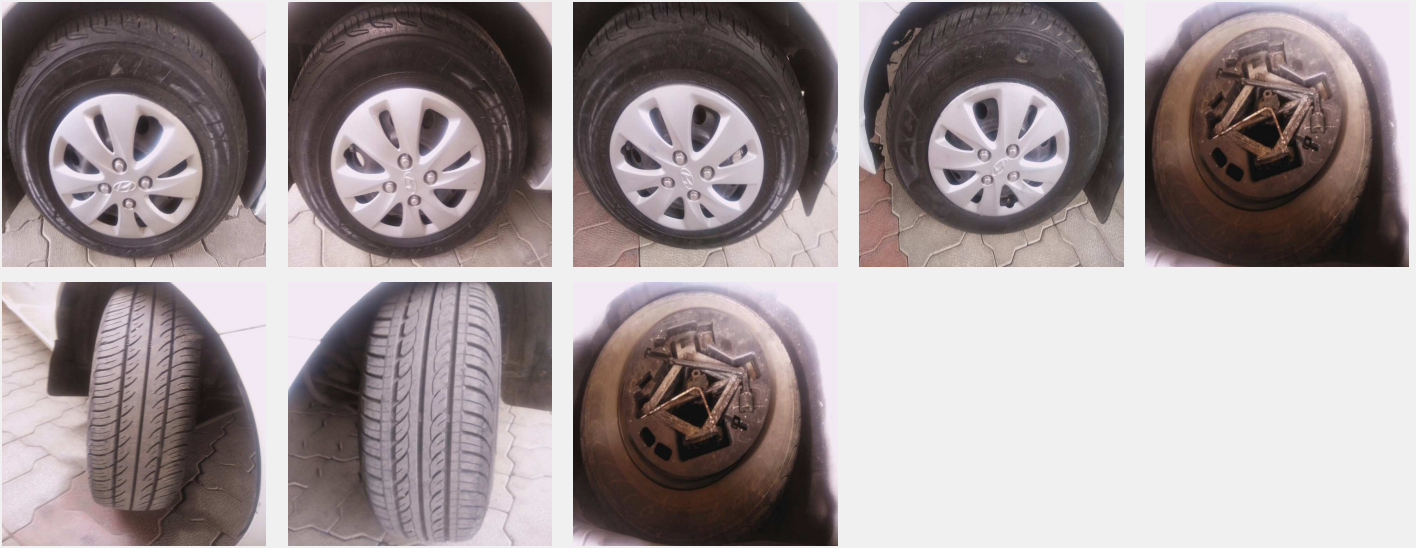
INSPECTION CHECKPOINTS	SCORE(X/10)	REMARKS/COMMENTS	OPTIONAL SPEND EST. (RS)
TYRES	8		0
SPARE TYRE (YES)	7		0
WHEEL ASSEMBLY (STEEL RIM)	8		0

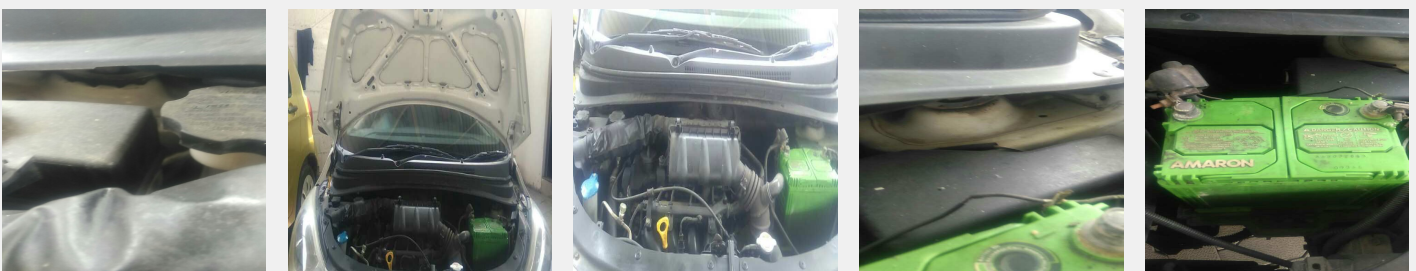
HOOD

INSPECTION CHECKPOINTS	SCORE(X/10)	REMARKS/COMMENTS	OPTIONAL SPEND EST. (RS)
LH APRON	8		0
RH APRON	8		0
RADIATOR	8		0
WIRING	8		0
BATTERY	8		0
BRAKE FLUID LEVEL	7		0
ENGINE OIL	7		0
COOLANT LEVEL	7		0
BRAKE & COOLANT HOSE PIPES	8		0
UNDERCARRIAGE	8		0
EXHAUST SYSTEM	8		0
