# ECO INSPECTION CERTIFICATE

121 Points Vehicle Inspection Certificate

Ordered By : Radhey	Inspection Date : 2019-06-12	Location : NOIDA

## Maruti Suzuki Celerio VXI, 2016

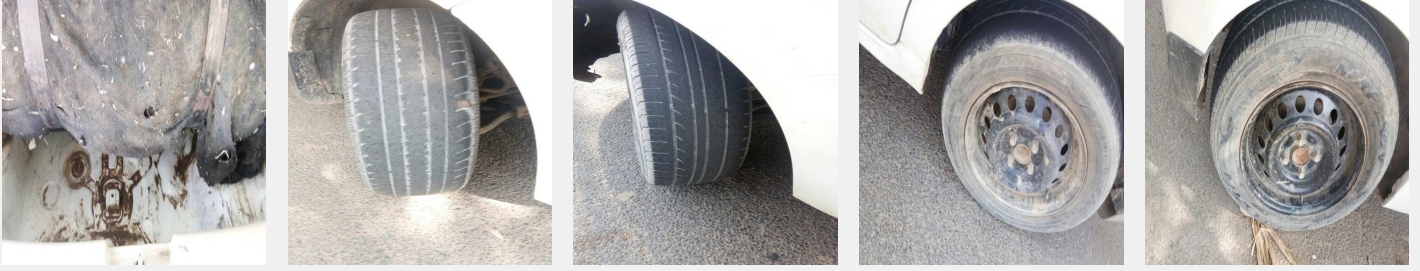
INSPECTION CHECKPOINTS	SCORE(X/10)	REMARKS/COMMENTS	OPTIONAL SPEND EST. (RS)
TYRES	6		0
SPARE TYRE (NO)	10		0
WHEEL ASSEMBLY (STEEL RIM)	7		0

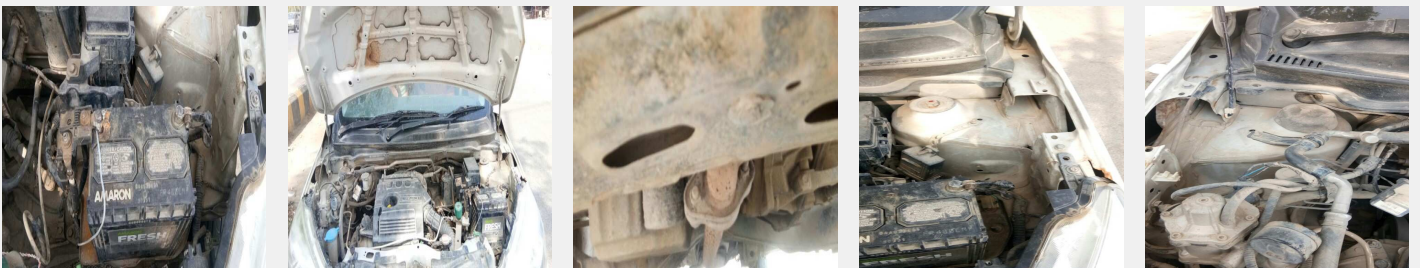
HOOD

INSPECTION CHECKPOINTS	SCORE(X/10)	REMARKS/COMMENTS	OPTIONAL SPEND EST. (RS)
LH APRON	6		0
RH APRON	6		0
RADIATOR	6		0
WIRING	6		0
BATTERY	6		0
BRAKE FLUID LEVEL	6		0
ENGINE OIL	6		0
COOLANT LEVEL	6		0
BRAKE & COOLANT HOSE PIPES	6		0
UNDERCARRIAGE	6		0
EXHAUST SYSTEM	6		0

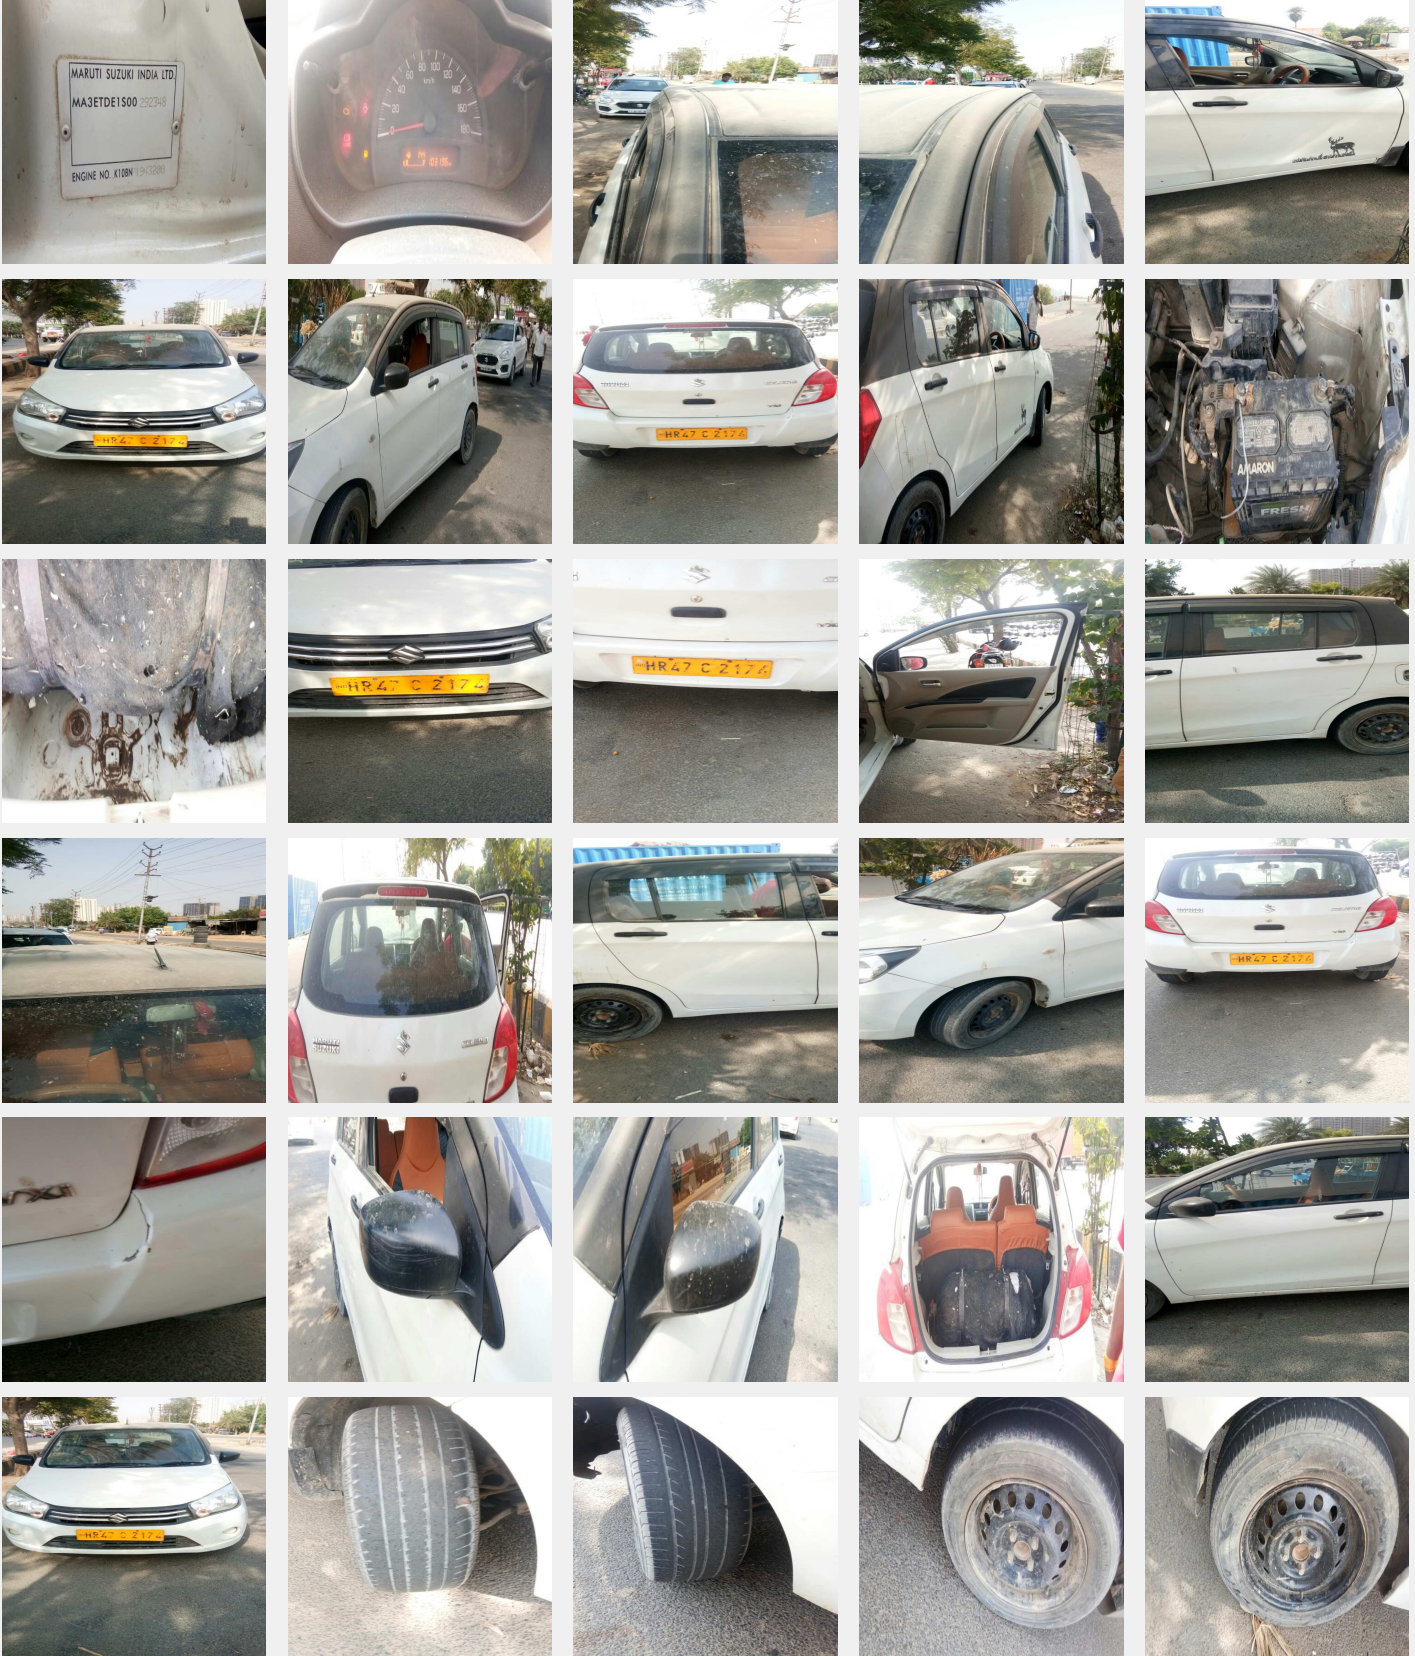
rear bumper is broken need to be change front right and left side suspension leeaage need to be ch
