# ECO INSPECTION CERTIFICATE

Order ID : 80475

121 Points Vehicle Inspection Certificate

## Volkswagen Polo 1.2 TDI HIGHLINE, 2011

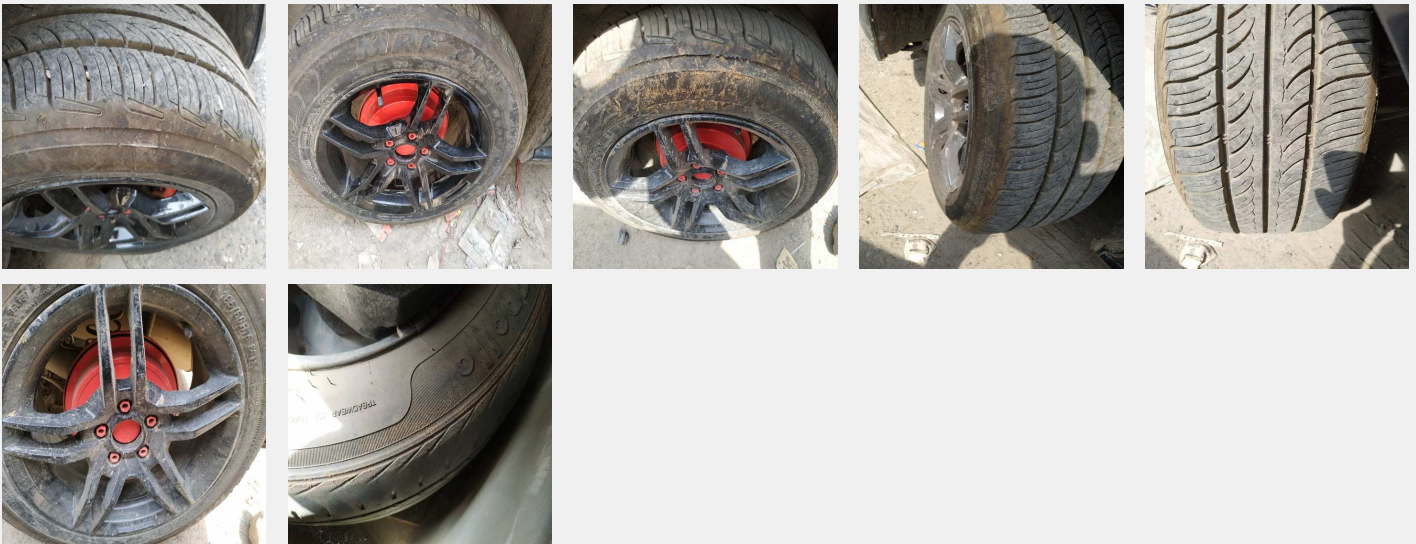
## WHEEL

INSPECTION CHECKPOINTS	SCORE(X/10)	REMARKS/COMMENTS	OPTIONAL SPEND EST. (RS)
TYRES	7		0
SPARE TYRE (YES)	7		0
WHEEL ASSEMBLY (ALLOY RIM)	7		0

tire change after the 20000km
