ECO INSPECTION CERTIFICATE

Order ID : 83793

121 Points Vehicle Inspection Certificate

Ford Ecosport TITANIUM 1.5L TI-VCT AT, 2014

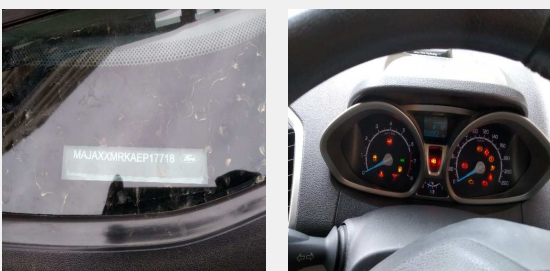
IMAGES

INSPECTION CHECKPOINTS	SCORE(X/10)	REMARKS/COMMENTS	OPTIONAL SPEND EST. (RS)
STEERING PERFORMANCE	8		0
BRAKE PERFORMANCE	8		0
CLUTCH PERFORMANCE	8		0
ENGINE NOISE	8		0
IGNITION SYSTEM	8		0
SUSPENSION PERFORMANCE	8		0
SUSPENSION FRONT SHOCKS	8		0
SUSPENSION REAR SHOCKS	8		0
TRANSMISSION ENGAGE	8		0
CRUISE CONTROL (NO)	10		0
REAR PARKING SENSORS (YES)	8		0
REAR VIEW CAMERA (YES)	8		0

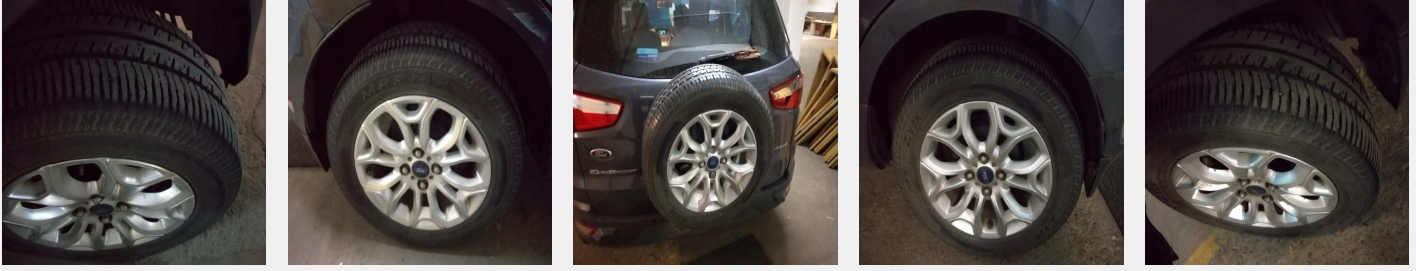
IMAGES

INSPECTION CHECKPOINTS	SCORE(X/10)	REMARKS/COMMENTS	OPTIONAL SPEND EST. (RS)
TYRES	7		0
SPARE TYRE (YES)	8		0
WHEEL ASSEMBLY (ALLOY RIM)	8		0

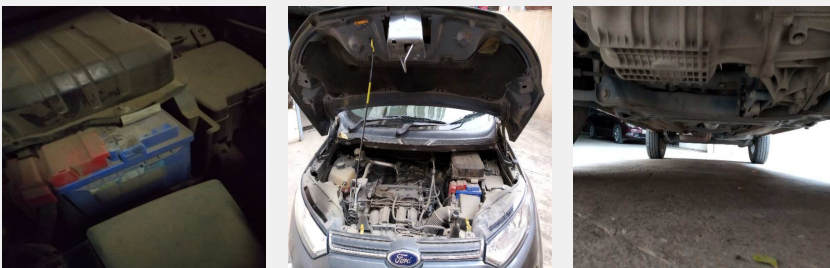
IMAGES

INSPECTION CHECKPOINTS	SCORE(X/10)	REMARKS/COMMENTS	OPTIONAL SPEND EST. (RS)
LH APRON	8		0
RH APRON	8		0
RADIATOR	8		0
WIRING	8		0
BATTERY	8		0
BRAKE FLUID LEVEL	8		0
ENGINE OIL	8		0
COOLANT LEVEL	8		0
BRAKE & COOLANT HOSE PIPES	8		0
UNDERCARRIAGE	8		0
EXHAUST SYSTEM	8		0
