# ECO INSPECTION CERTIFICATE

121 Points Vehicle Inspection Certificate

Inspection Date :  
2019-06-19

## Maruti Suzuki Ertiga Zdi+ Shvs, 2016

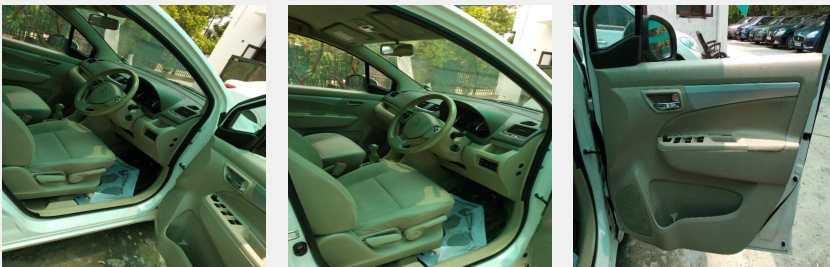
## IMAGES

INSPECTION CHECKPOINTS	SCORE(X/10)	REMARKS/COMMENTS	OPTIONAL SPEND EST. (RS)
DOOR PANEL	8		0
DOOR HINGES	8		0
CARPET & FLOOR MAT	7		0
SEAT & SEAT BELT	8		0
DASHBOARD & INSTRUMENT PANEL	8		0
HORN	8		0
SPEAKERS & MUSIC SYSTEM	8		0
HANDBRAKE	8		0
STEERING-MOUNTED CONTROLS	8		0
PEDALS	8		0
CENTRAL LOCK	8		0
A/C VENTS & HEATER	8		0
CUP HOLDERS	8		0
NAVIGATION (NO)	10		0
ODOMETER	8		0
POWER WINDOWS (YES)	8		0
HAZARD LIGHT	8		0

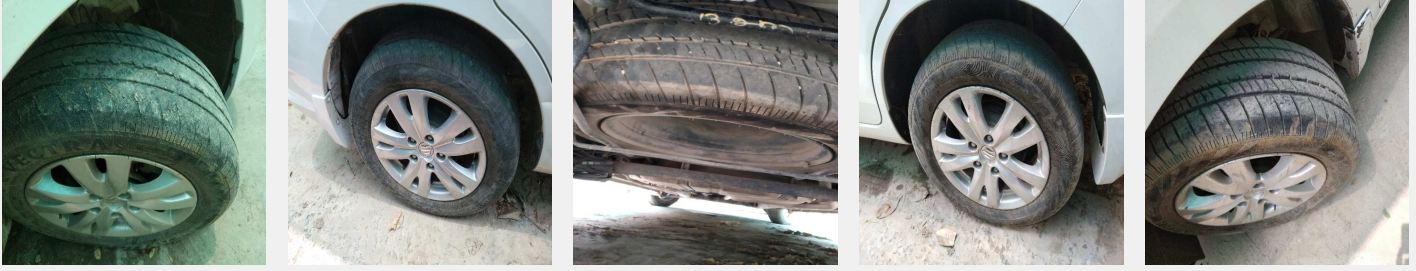
IMAGES

INSPECTION CHECKPOINTS	SCORE(X/10)	REMARKS/COMMENTS	OPTIONAL SPEND EST. (RS)
TYRES	7		0
SPARE TYRE (YES)	8		0
WHEEL ASSEMBLY (ALLOY RIM)	8		0

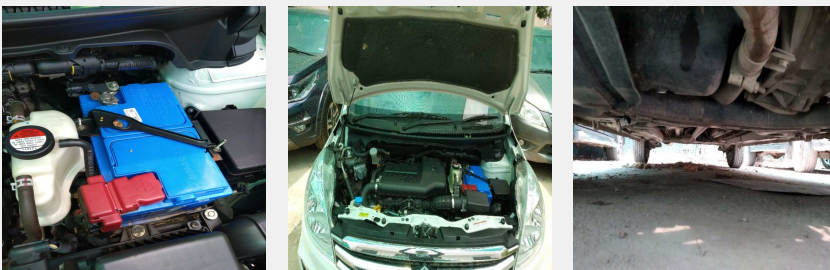
IMAGES

INSPECTION CHECKPOINTS	SCORE(X/10)	REMARKS/COMMENTS	OPTIONAL SPEND EST. (RS)
LH APRON	8		0
RH APRON	8		0
RADIATOR	8		0
WIRING	8		0
BATTERY	8		0
BRAKE FLUID LEVEL	8		0
ENGINE OIL	8		0
COOLANT LEVEL	8		0
BRAKE & COOLANT HOSE PIPES	8		0
UNDERCARRIAGE	8		0
EXHAUST SYSTEM	8		0

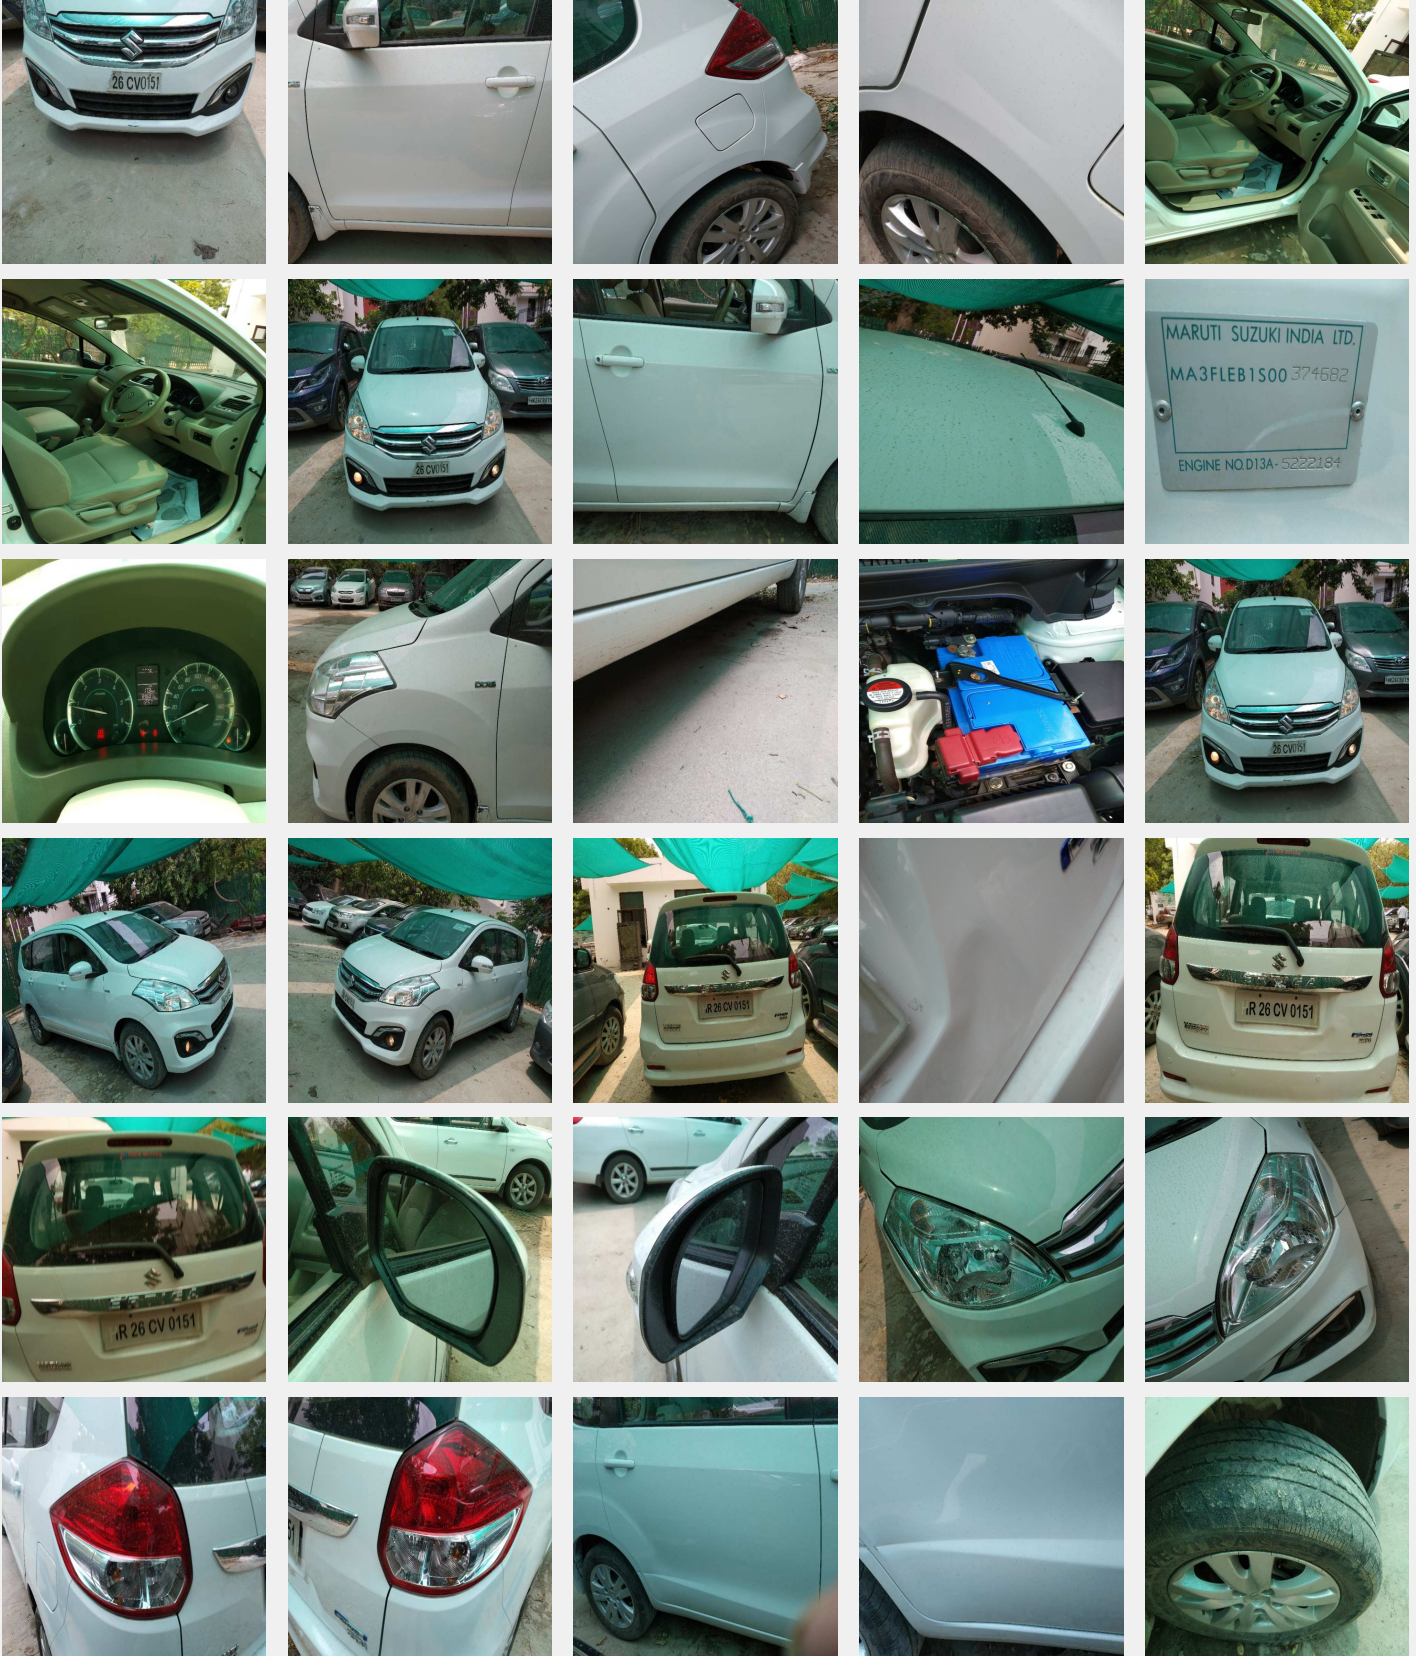
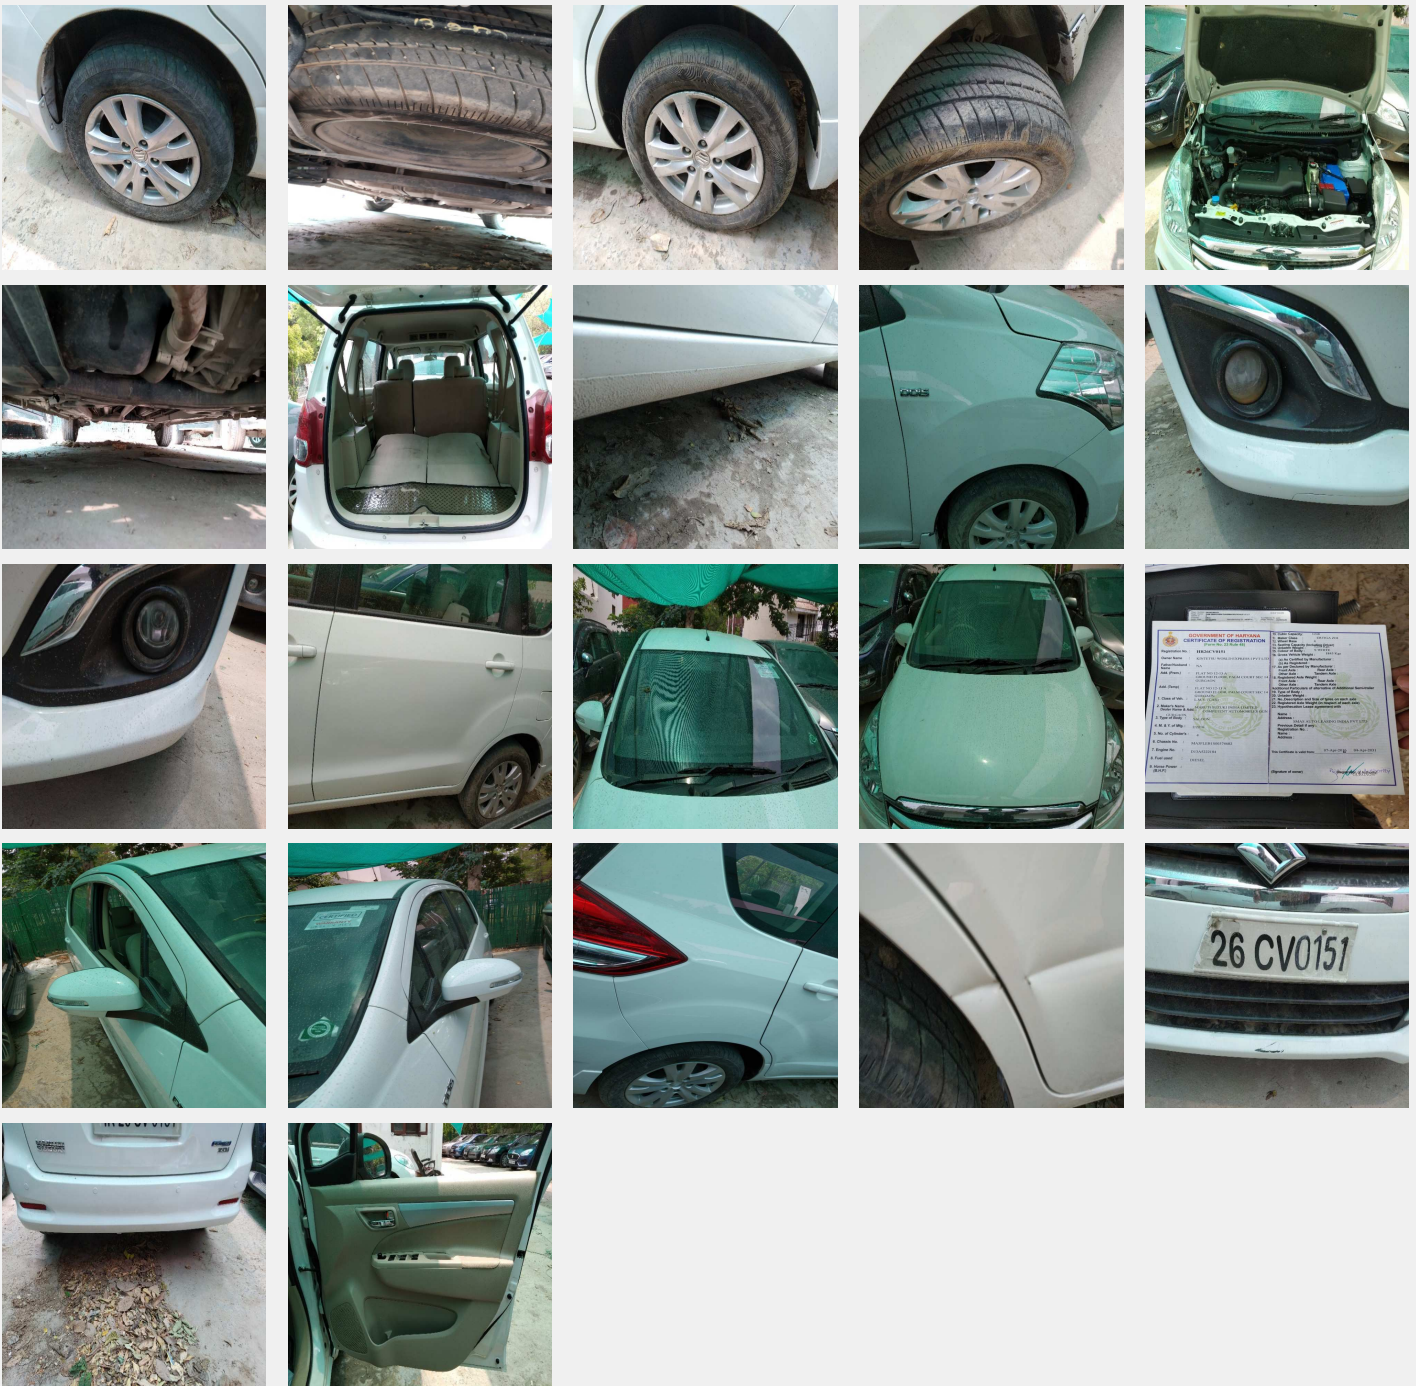
IMAGES

car fully painted minor dent all tyres already replaced
