ECO INSPECTION CERTIFICATE

Order ID : 95263

121 Points Vehicle Inspection Certificate

Mahindra Scorpio S4 PLUS 1.99, 2015

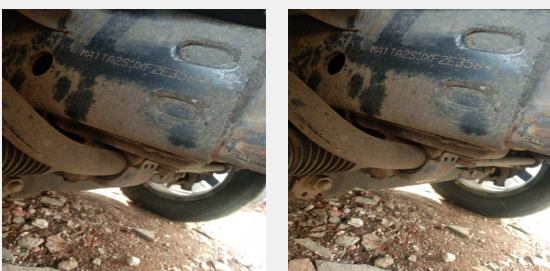
IMAGES

INSPECTION CHECKPOINTS	SCORE(X/10)	REMARKS/COMMENTS	OPTIONAL SPEND EST. (RS)
STEERING PERFORMANCE	7	OK	0
BRAKE PERFORMANCE	8	OK	0
CLUTCH PERFORMANCE	8	OK	0
ENGINE NOISE	8	OK	0
IGNITION SYSTEM	8	OK	0
SUSPENSION PERFORMANCE	8	OK	0
SUSPENSION FRONT SHOCKS	9	OK	0
SUSPENSION REAR SHOCKS	8	OK	0
TRANSMISSION ENGAGE	9	OK	0
CRUISE CONTROL (YES)	8	OK	0
REAR PARKING SENSORS (YES)	8	OK	0
REAR VIEW CAMERA (YES)	8	OK	0
