# ECO INSPECTION CERTIFICATE

Order ID : 95750

121 Points Vehicle Inspection Certificate

## Toyota Etios Liva GD SP, 2014

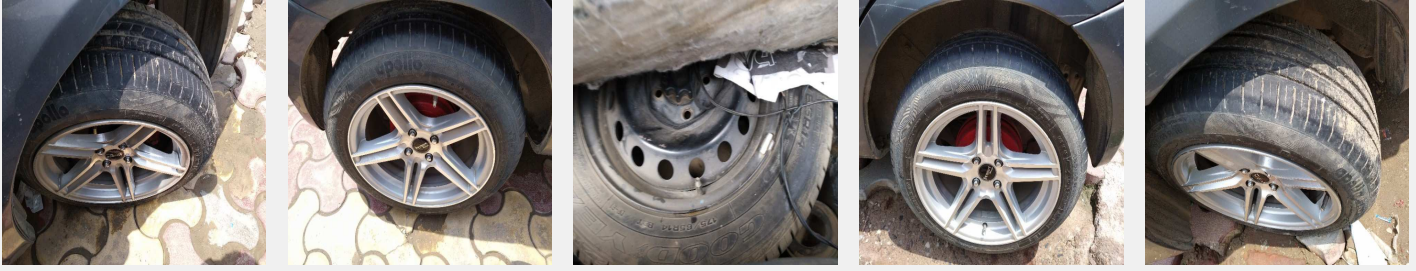
IMAGES

INSPECTION CHECKPOINTS	SCORE(X/10)	REMARKS/COMMENTS	OPTIONAL SPEND EST. (RS)
TYRES	7		0
SPARE TYRE (YES)	8		0
WHEEL ASSEMBLY (ALLOY RIM)	8		0

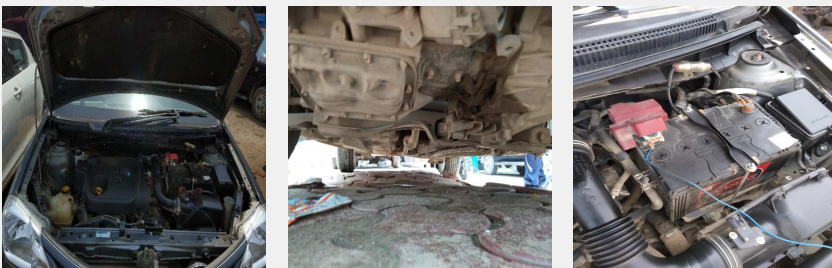
IMAGES

INSPECTION CHECKPOINTS	SCORE(X/10)	REMARKS/COMMENTS	OPTIONAL SPEND EST. (RS)
LH APRON	8		0
RH APRON	8		0
RADIATOR	8		0
WIRING	8		0
BATTERY	8		0
BRAKE FLUID LEVEL	8		0
ENGINE OIL	8		0
COOLANT LEVEL	8		0
BRAKE & COOLANT HOSE PIPES	8		0
UNDERCARRIAGE	8		0
EXHAUST SYSTEM	8		0
